OMAE-91-512 / AQ-305-90 / 24.9.1990

IN SERVICE EXPERIENCE OF FIXED OFFSHORE
STRUCTURES IN NORWAY

Norwegian Petroleum Directorate (NPD)
Stavanger, NORWAY

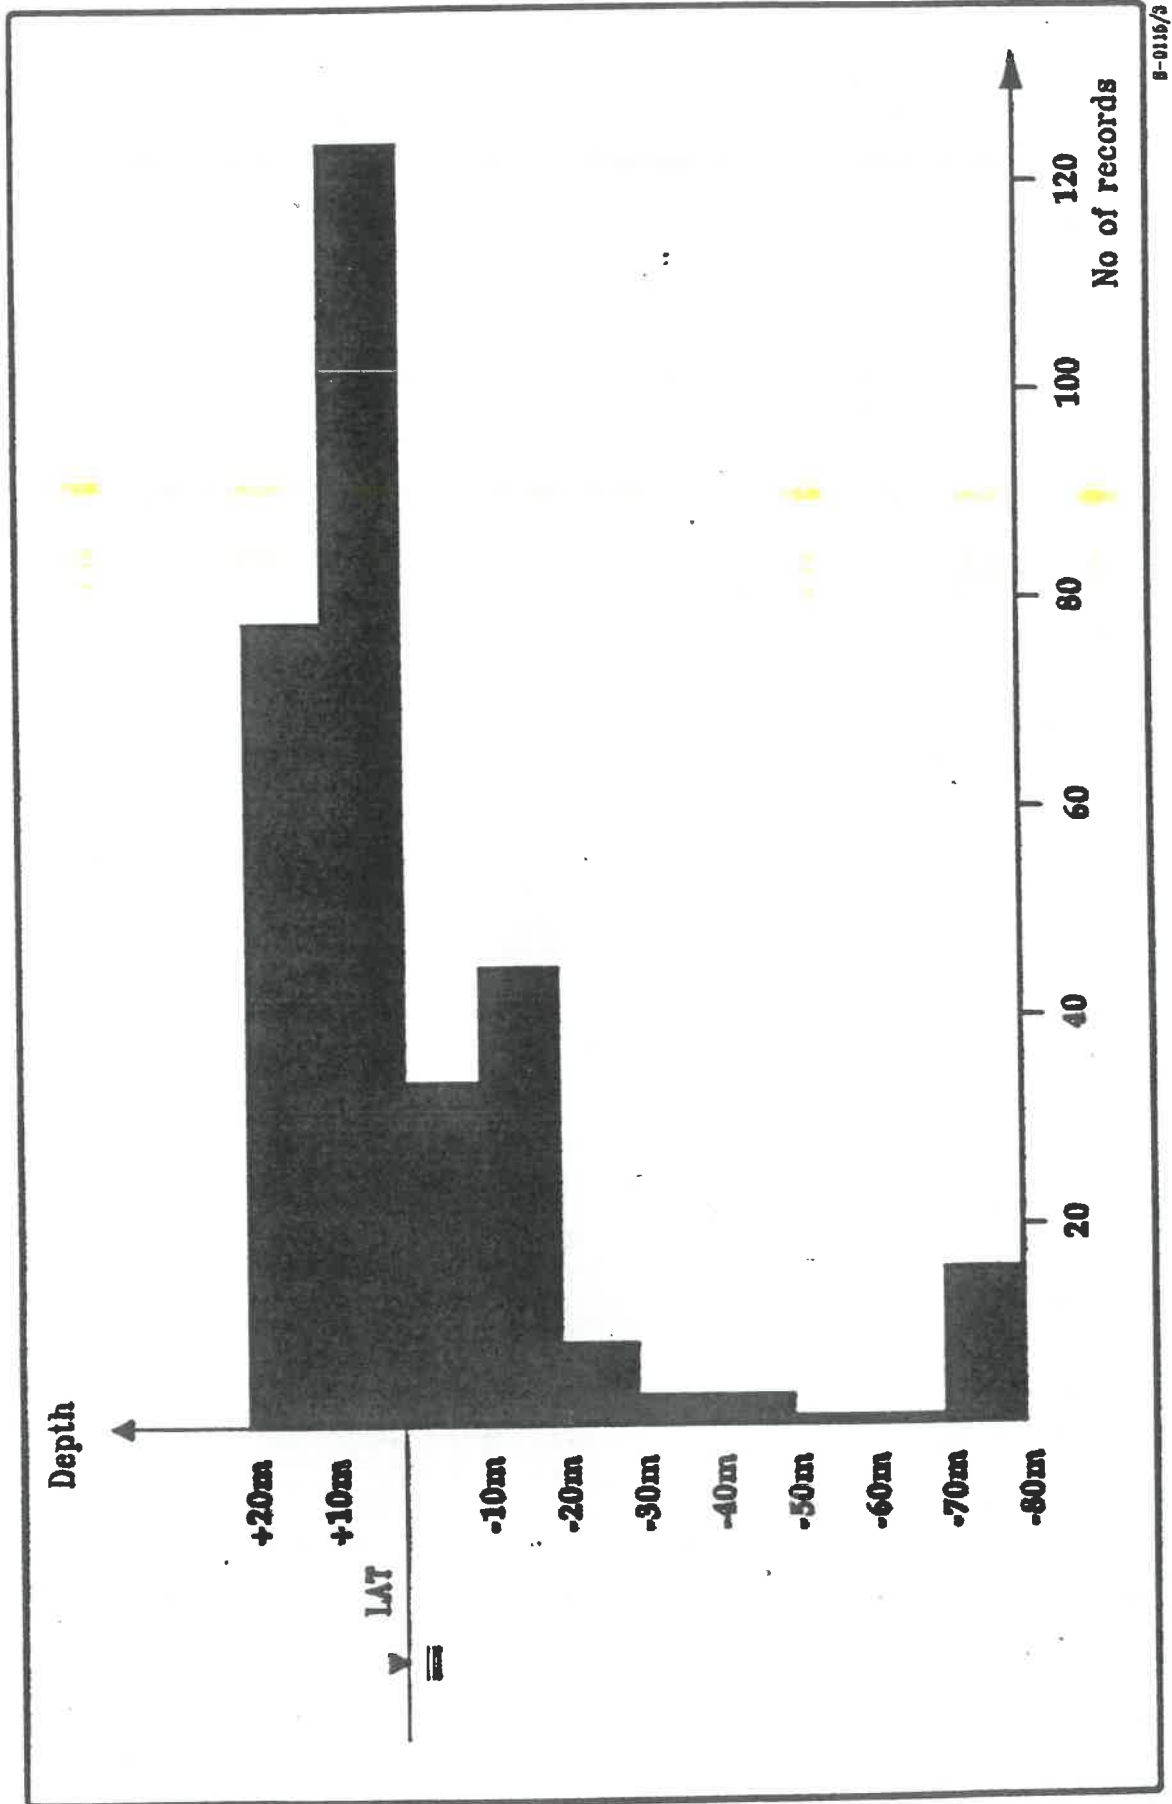
A total of 28 cracks are in CODAM directly related to bad workmanship during fabrication. These cracks have been discovered on different platforms during a long period of time. The real number is probably significantly higher. An indication can be found by reviewing the number of cracks. Figure 2 gives the number of cracks on norwegian platforms as a function of the location on the platform.

CRACKS
