Investigation report

Report title Report from the investigation of the listing of <i>Floatel Superior</i> , 7 November 2012 on the Njord field	Activity number 420001003
---	------------------------------

An unsecured anchor caused water intrusion in two tanks on *Floatel Superior* during the night of 6-7 November 2012, leading to a list of 5.8°. The extent of the damage and the potential consequences of further water intrusion then prompted a decision to evacuate. The evacuation of 336 people was carried out by helicopter. None of the 374 people on *Floatel Superior* suffered any personal injury as a result of the incident.

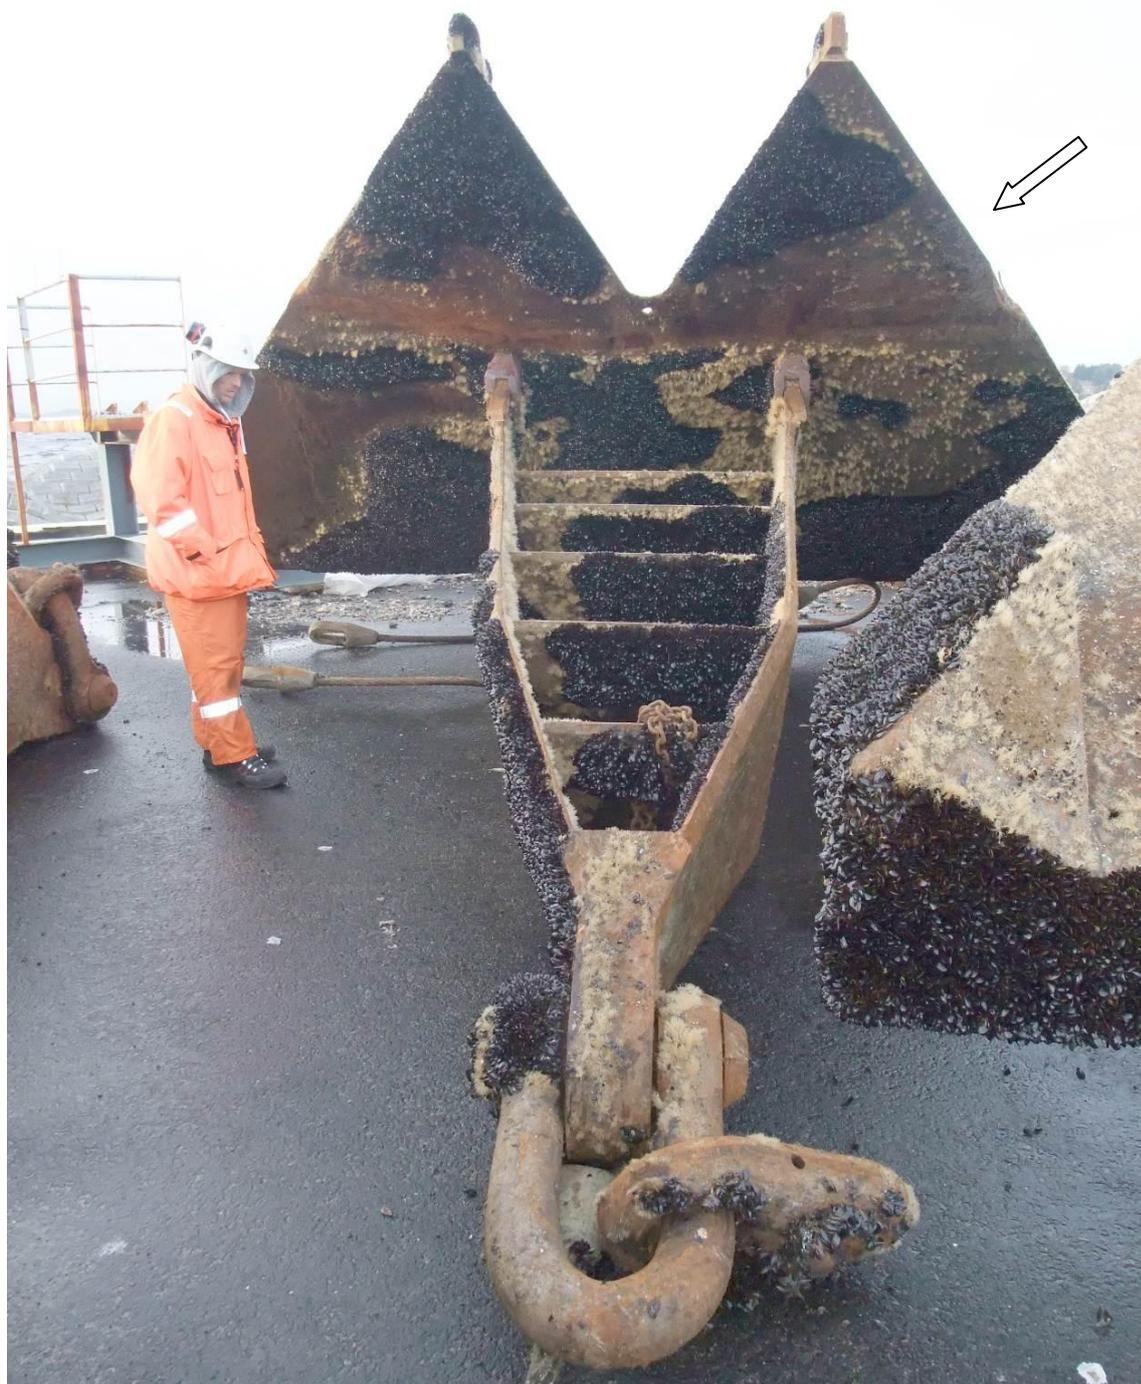
Figure 2: A 12-tonne Bruce anchor from *Floatel Superior*. The photograph shows anchor 1 from the starboard side after removal. The scratch marks where marine fouling (the blue-black colour of the mussels) has been removed show that the anchor has rotated as well as moved from side to side (see the fan shape on the right-hand side of the fluke, arrowed). See also Figure 14, which shows various positions taken by the anchor. The anchor fluke is the large plate topped by two points. The photograph was taken by the PSA on 14 November 2012 in Kristiansund.

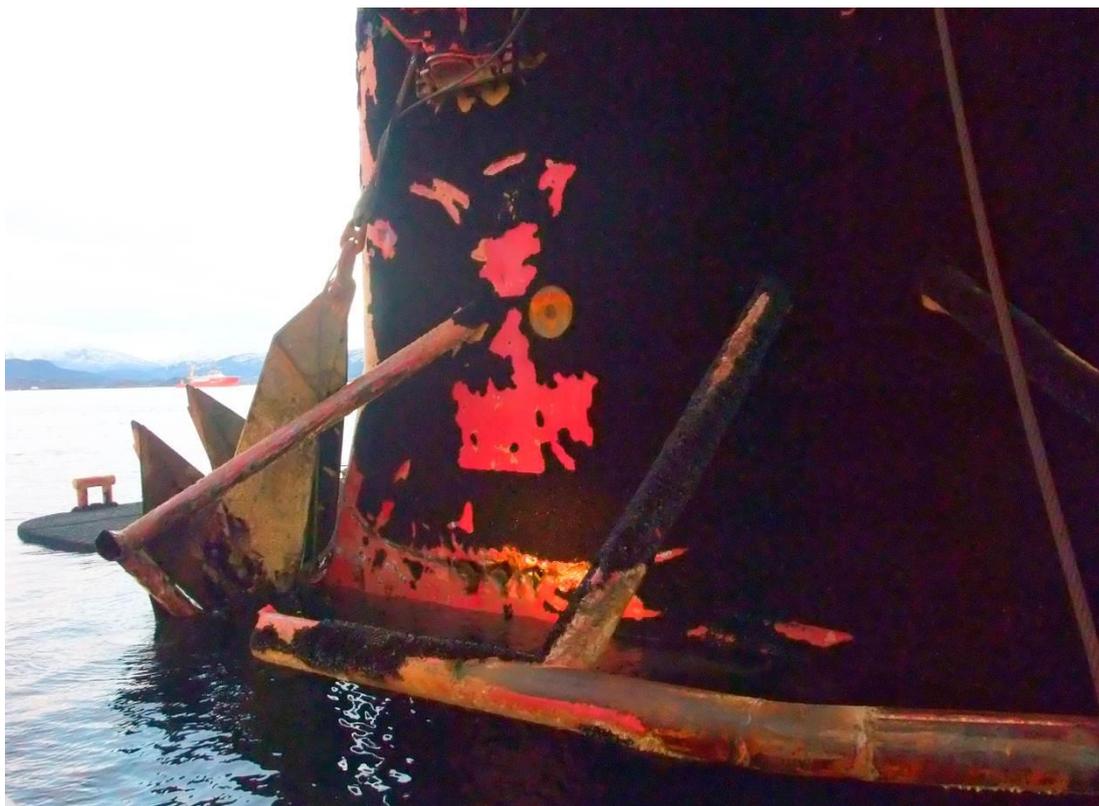
Figure 3: Anchor 8 and the damage above the waterline, here at transit draft. The anchor which caused the damage and the partly destroyed bolster are visible. The photograph was taken by the PSA on 10 November 2012 in Kristiansund.

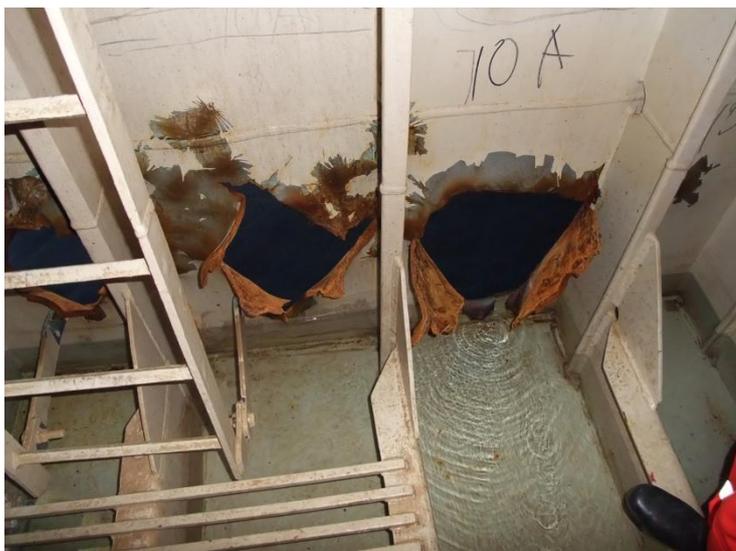
Figure 4: Three of holes in tank 10A viewed from inside. The photograph was taken in Kristiansund during November 2012 by the PSA.

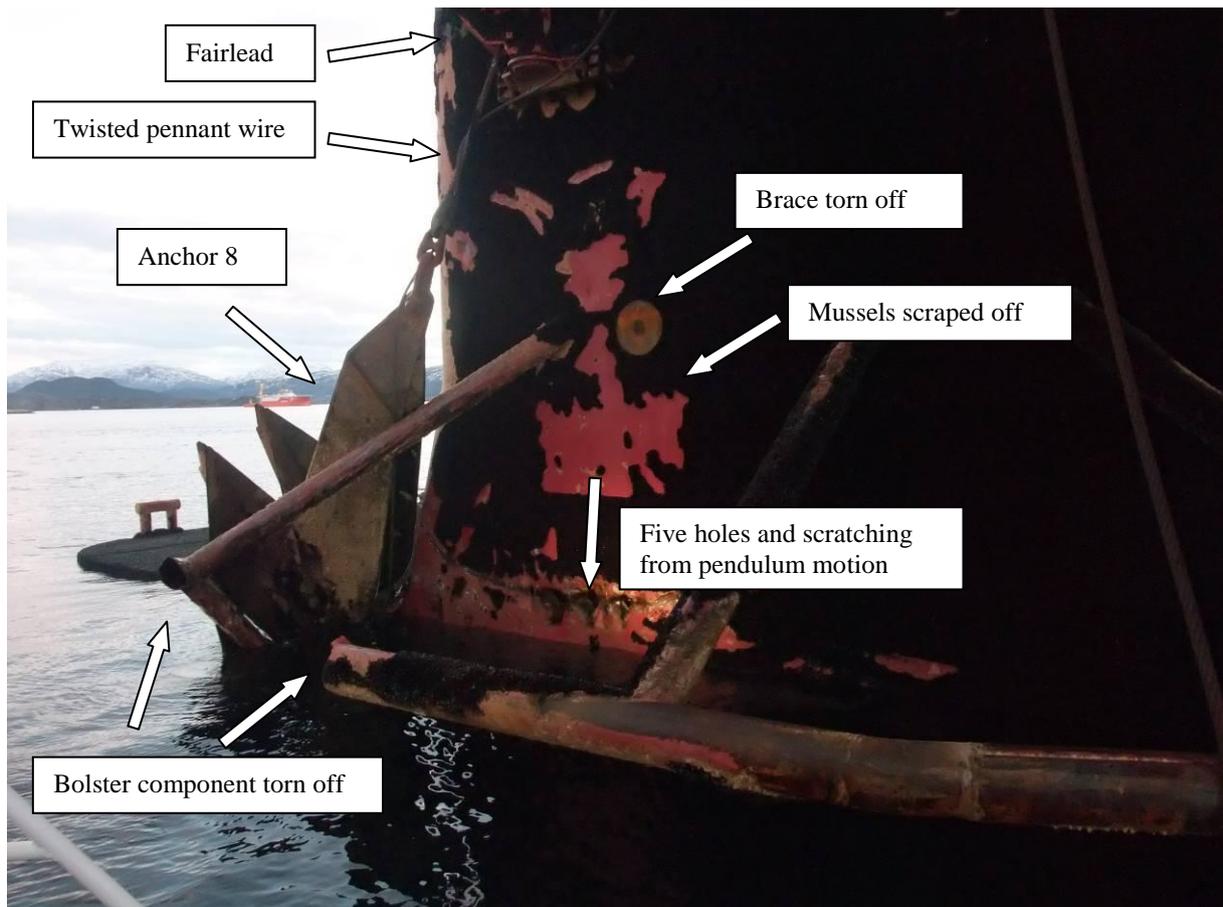
Figure 7: The damage site at anchor 8 after arrival in Kristiansund on 10 November 2012. Anchor 7 has been removed from its place to the right of the picture. Five holes can be seen in the hull just above the waterline (see arrows). The circular mark has been left by the torn-off brace. The black areas are covered with mussels and the hull is painted red. Red areas show where mussels have been peeled off from contact with the anchor and lines. The anchor is rotated, with a twisted pennant wire. The facility is in its transit draft of about 8.5 metres. At survival draft, the mean waterline is at the uppermost fixings of the bolster, to the right at the top of the picture. The photograph has been taken by the PSA.

Crew in the forward port column had heard noises and blows from outside the hull, and continued to investigate what had caused the water intrusion in tank 10. On deck, it was reported at about 03.45 that the railings on the stern side of the operating house for anchor winch 4 had been damaged [1]. From the observation point beside winch 3 (the level below the cabin), the bolster at anchor 8 was seen to be damaged and anchor 8 was not in its usual place (was gone). The sight line from anchor winch 3 to anchor 8 runs along the side of *Floatel Superior*. Anchor 8 was located from the observation point at winch 4 (the level below the operating house for that winch). At that time, the anchor was at rest on the wrong side of the bolster brace, wedged between the forward side of the column, the pontoon deck and the bolster structures²⁰. That location corresponds roughly to what could be observed on arrival in Kristiansund, see Figure 7.

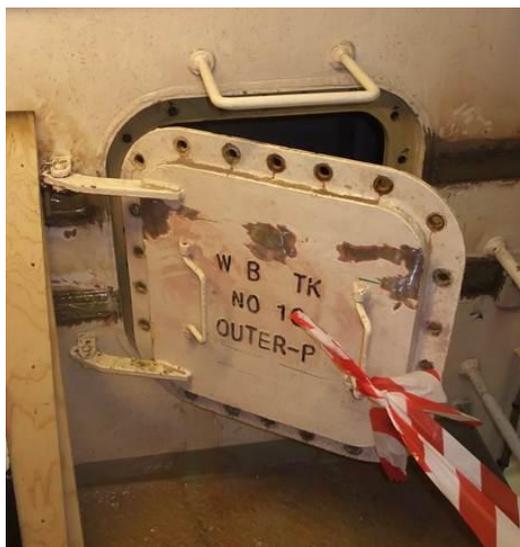
Figure 8: Hatch from the central column to ballast tank WB TK NO 10 OUTER-P. Marks from the reinforcement temporarily welded on during 7 November 2012 are visible where the paint has gone. Seal and bolts are removed. Photograph taken by the PSA in Kristiansund on 12 November 2012

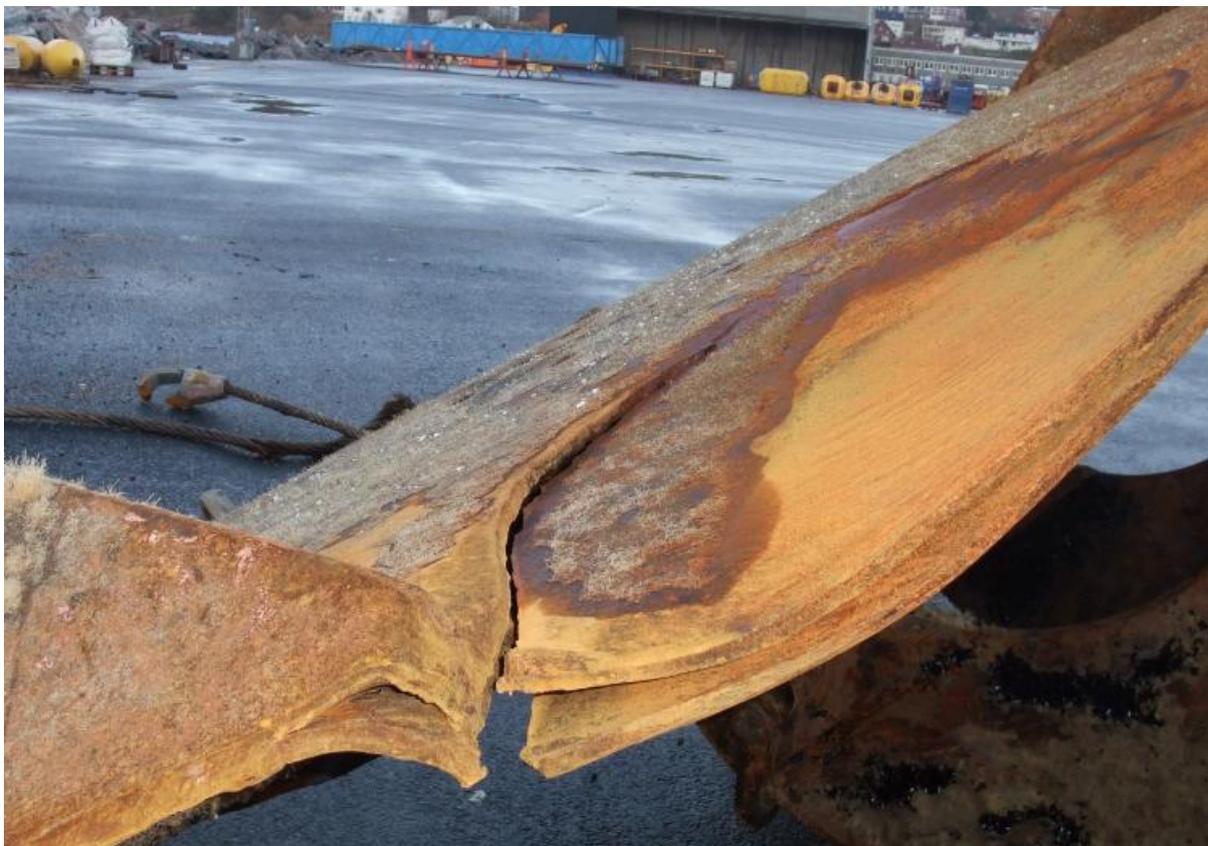
Figure 10: Damage to anchor 8 on *Floatel Superior*, photographed in Kristiansund on 14 November 2012 by the PSA.

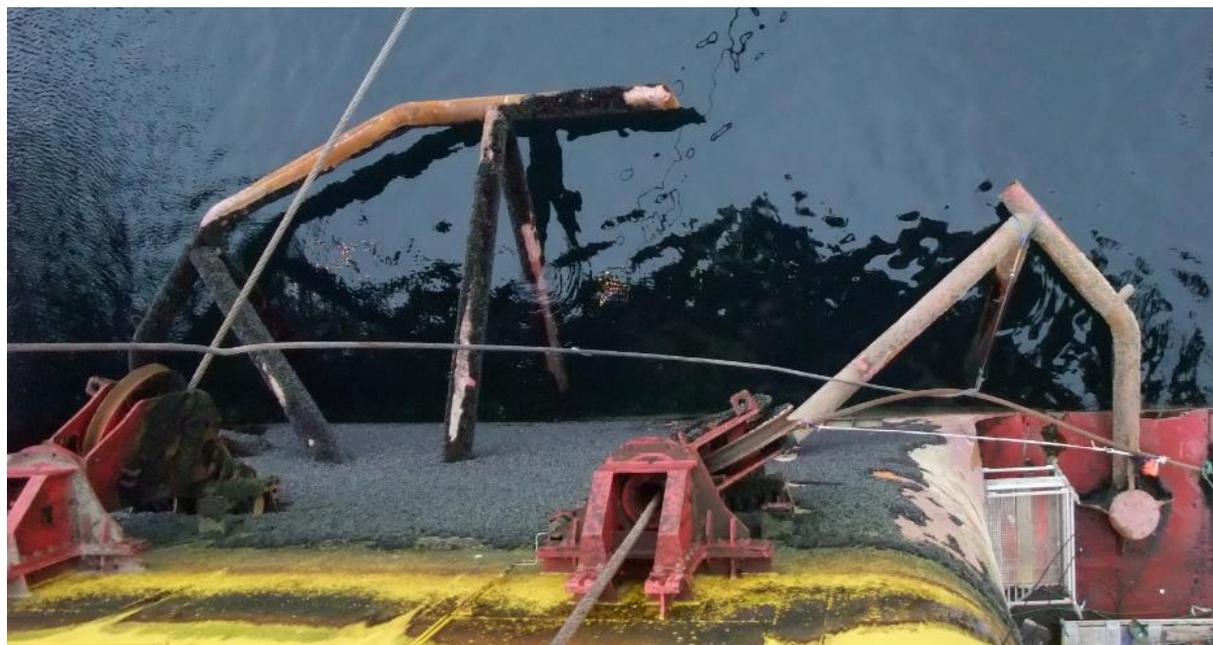
Figure 12: The bolster after the damage. Line 7 is to the left and line 8 on the right. Line 7 has been used here for mooring to land. The line running across the picture is the pennant wire. A comparison with Figure 11 shows which components have fallen off. The photograph was taken in Kristiansund on 13 November 2012 by the PSA.

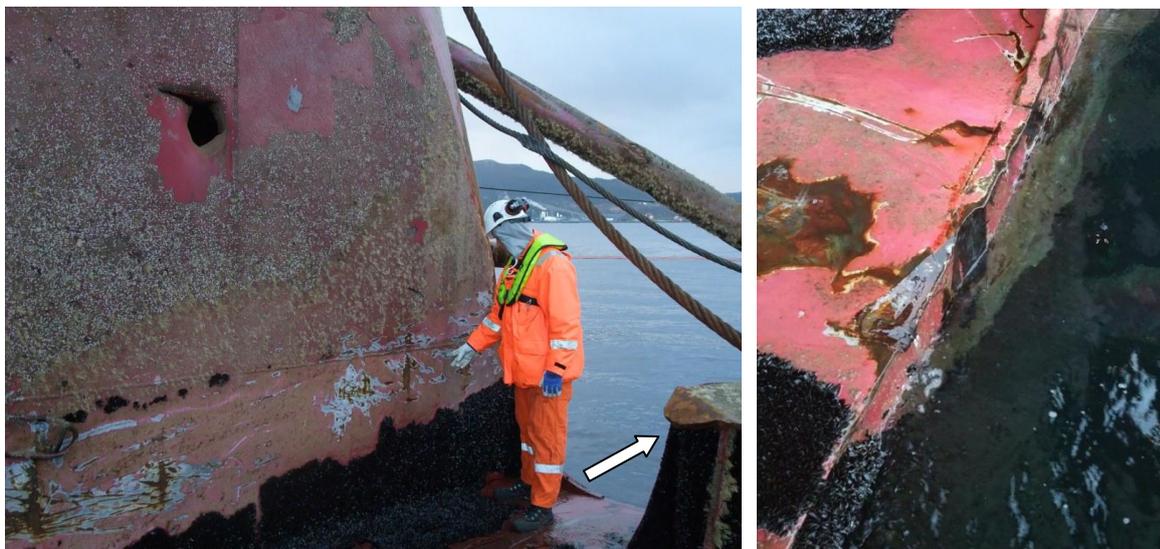
Figure 13: The hull at the front of the column outside tank 10. A simple penetration before the anchor has become wedged between hull and bolster components. Note the bent plate marked with an arrow in the left-hand picture. The picture to the right shows extensive wear on hull plates outside tank 2. The photographs have been taken by the PSA in Kristiansund on 12 November 2012.

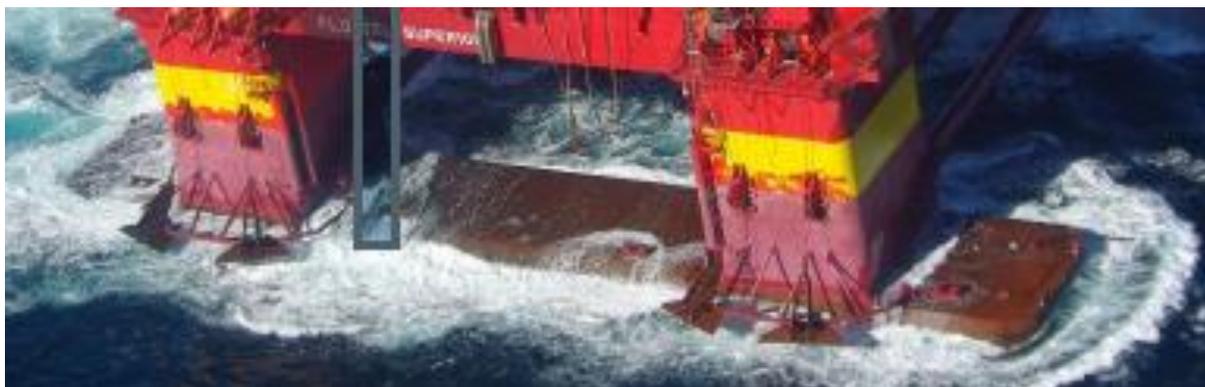
Figure 26: Detail from a photo which shows one anchor (anchor 1 at far right) out of position with its fluke against the lower brace on the bolster while under tow at transit draft on 24 August 2010. Photograph: Floatel International [73].

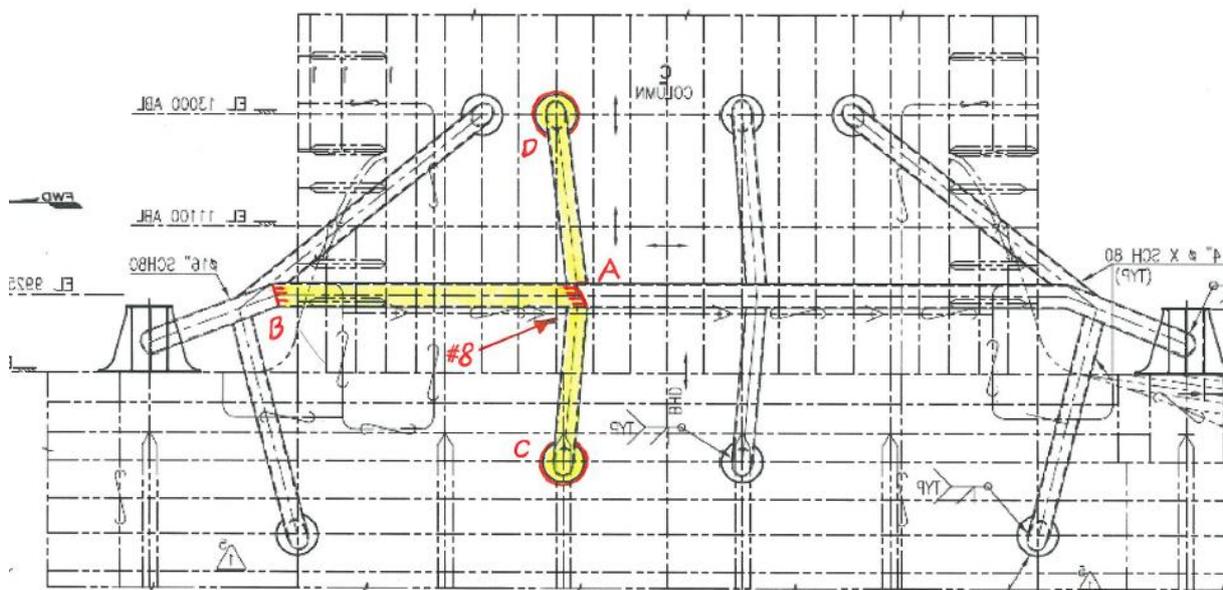
Figure 27: Detail of drawing with the extent of the damage to the bolster at anchor 8 sketched in. Arrow marked #8 indicates the most likely position of the anchor before the damage developed. A, B, C and D show the four fractures in the bolster structure. Yellow indicates which components fell off. From the Keppel Fels design drawing [58] with our notations in yellow and red.

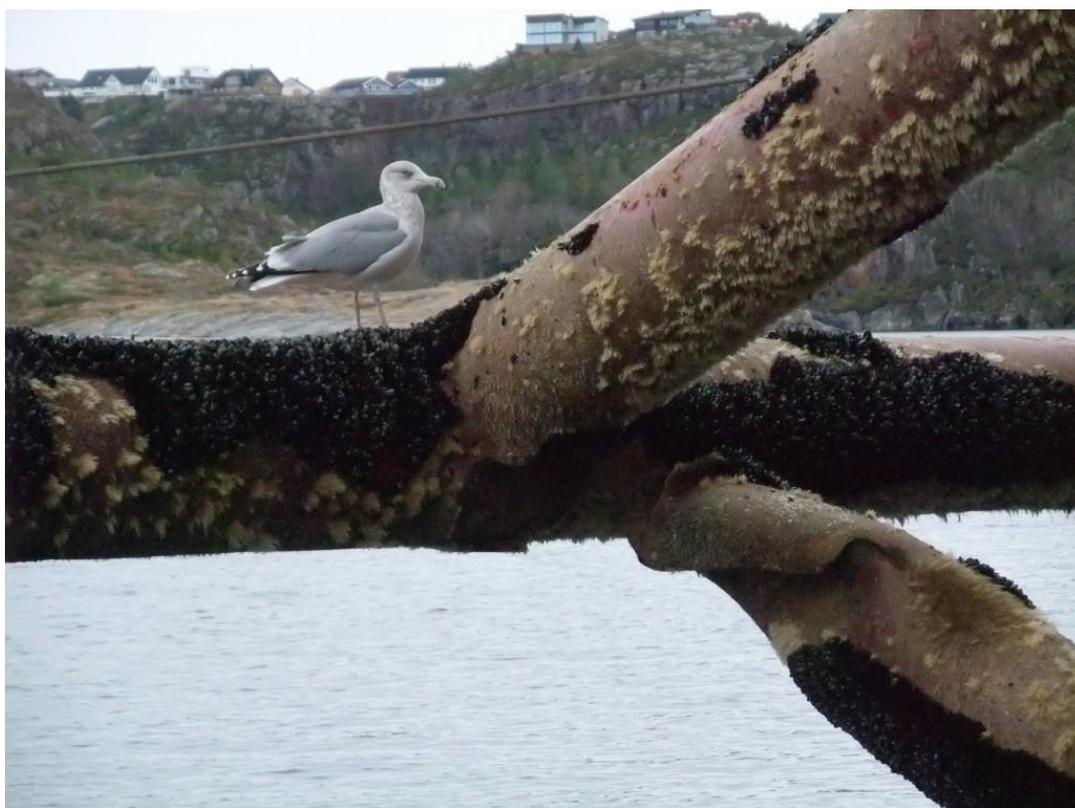
Figure 28: The bolster on the forward port side. Anchor 1 has hit the brace under the bolster bar. Note that the lower brace has been ripped off completely and shifted about one diameter aft (to the right in the photo), and is thereby attached at only point on the side of tank 3A starboard. The damage is not the outcome of a sudden fracture, but has big deformations from action over a long time. The bolster at anchor 8 (A in Figure 27) has probably suffered similar damage on the evening of 6 November 2012 (all the anchors have damaged bolsters). The photograph was taken in Kristiansund on 13 November 2012 by the PSA.

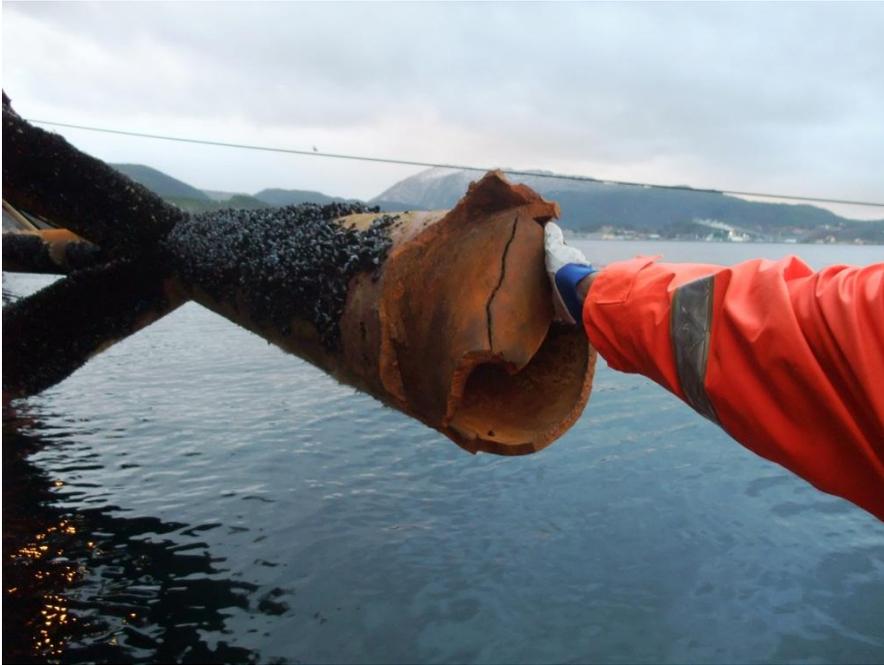
Figure 29: Bolster 4 with damage A (see Figure 27). Three components are missing at this point. The first fracture on the incident night is assumed to have occurred here at 23.40 on 6 November, when overload alarms on the anchor winch ceased. Until then, the anchor could have pulled with a load of 70-80 tonnes in the horizontal bolster bar A-B (see Figure 27). The fracture has developed from the earlier damage, which is thought to have occurred in the lower brace (see Figure 28). This fracture caused a reduction in the anchor load, and allowed the anchor to start moving. The bolster bar between A and B may have remained for a time. After about two hours, the anchor has been able to hit the hull. Before that, the bolster has suffered yet another weld fracture at B and the bar – weighing about 1.5 tonnes – has fallen to the seabed. Both braces have been present until 01.40, with the upper probably still attached to point B (where the hand in the photo is holding a component which was bent after 01.40). The photograph was taken in Kristiansund on 12 November 2012 by the PSA.

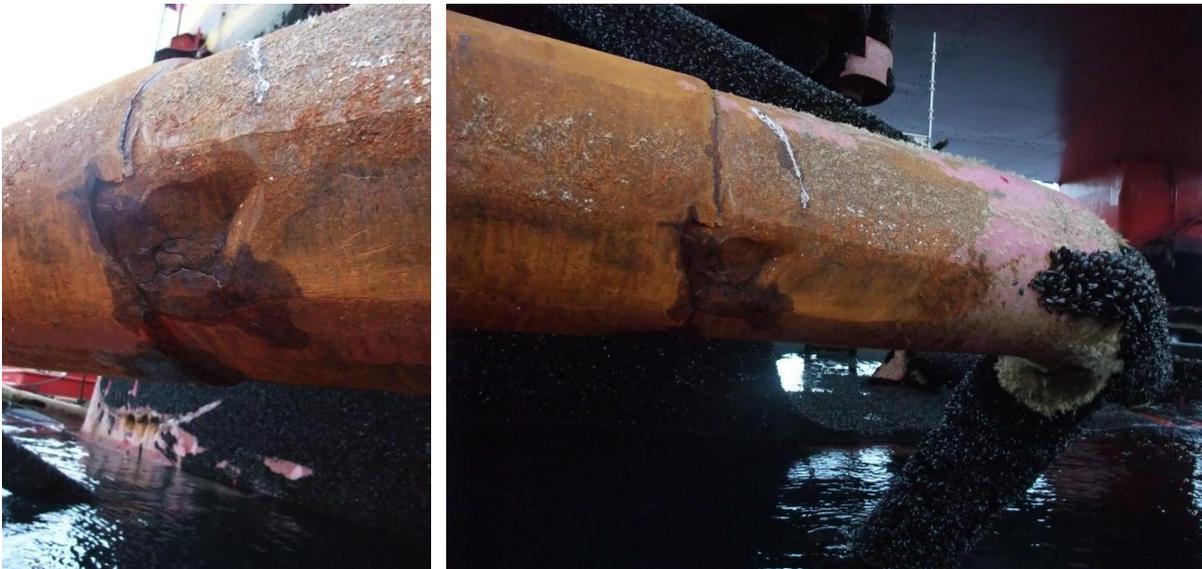
Figure 30: Wear damage where anchor 7 has been wrongly positioned on the bolster (towards the aft of *Floatel Superior*) and worn bolster material and wear surfacing on the edge of the wear surface (left). Note also the surface which has been scraped smooth on the bolster base material to the right. These observations are interpreted to mean that anchor 7 (and other anchors similarly) moved for long periods outside the dedicated position on the bolster's wear surface. In addition, the local wear on the edge of the wear surface is interpreted to show that the anchor has been "locked" in this position and that a high counter-pressure has led to extensive local wear. With movements of the anchor from the centre of the wear surface, the geometry of the bolsters causes the wire rope to elongate. This design is intended to

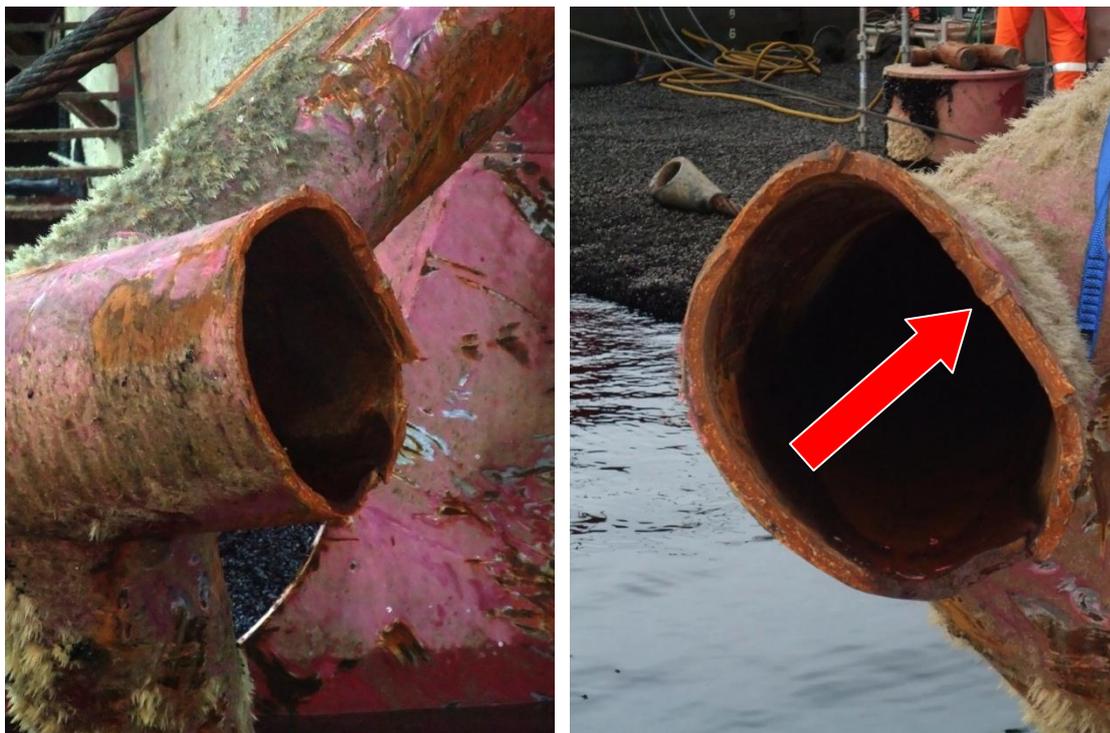
Figure 31: Fracture surface B on the bolster, see Figure 27. The fracture has developed from the circumferential weld at the bend in the bolster geometry. Note that the final stage of the fracture could have developed as a tension fracture from the anchor tension (along the arrow), and the cross section has been deformed to a straight section before this component was torn off and the A-B bolster section fell off shortly before 01.40. The photographs were taken in Kristiansund on 12 November 2012 by the PSA.

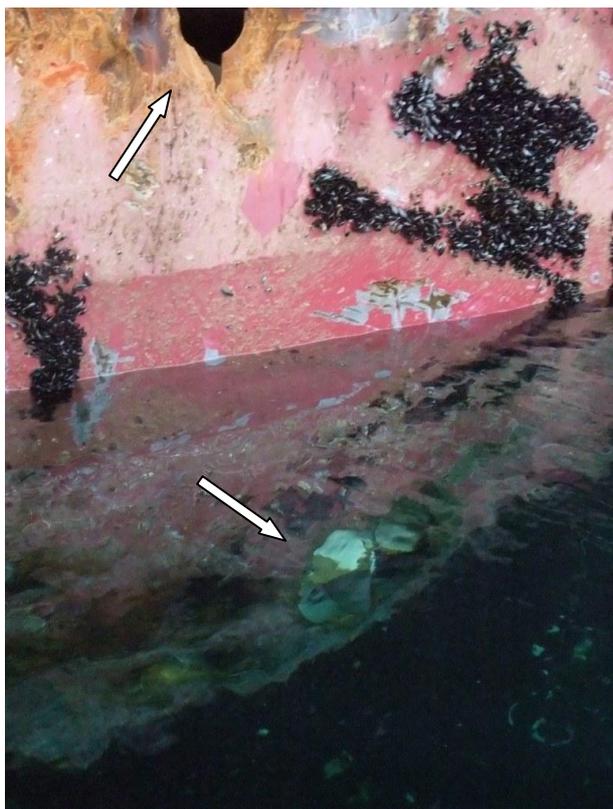
Figure 32: Hole beneath the waterline at bolster damage C (see Figure 27), where the doubling plate has been ripped off to hole the hull's outer plating. Note the bottom edge of the anchor penetration at the top of the photo, and the waterline with transit level in the middle. The photograph was taken in Kristiansund on 12 November 2012 by the PSA.

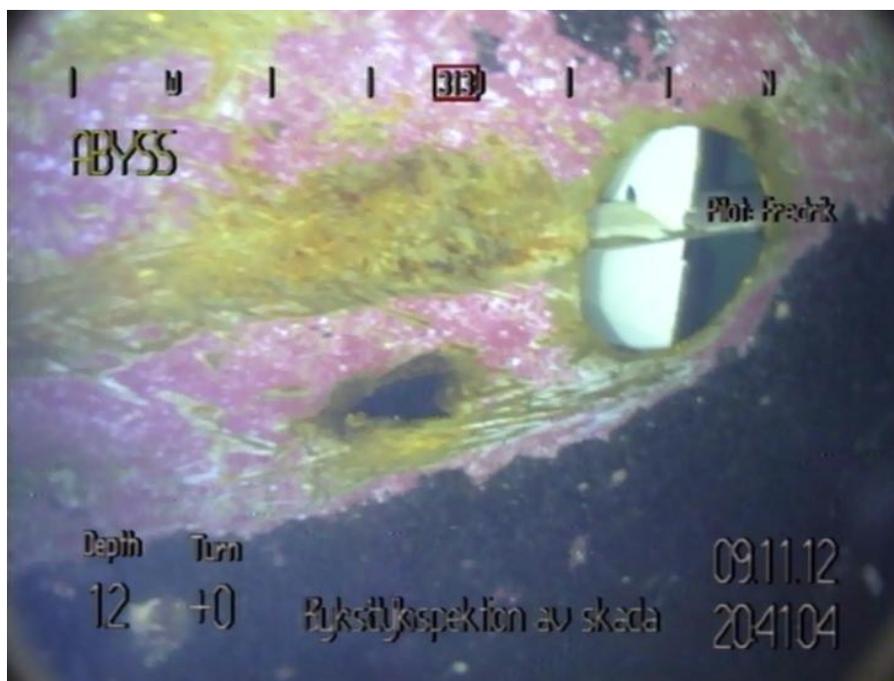
Figure 33: The two holes through the hull into tank 3A. Most clearly visible is the circular hole where the C brace fixing (see Figure 27) has broken off the hull, with the development of cracks along the weld between doubling plate and hull. Observe that the cross-stiffening with L profiles remains in place on the inside of the hull. The hole diameter is 700 millimetres. To the left can be seen the hole created through penetration from the corner behind by the fluke of anchor 8. The damage is assumed to be the first penetration (about 01.40), and has occurred while the anchor has had its “back” to the brace which was

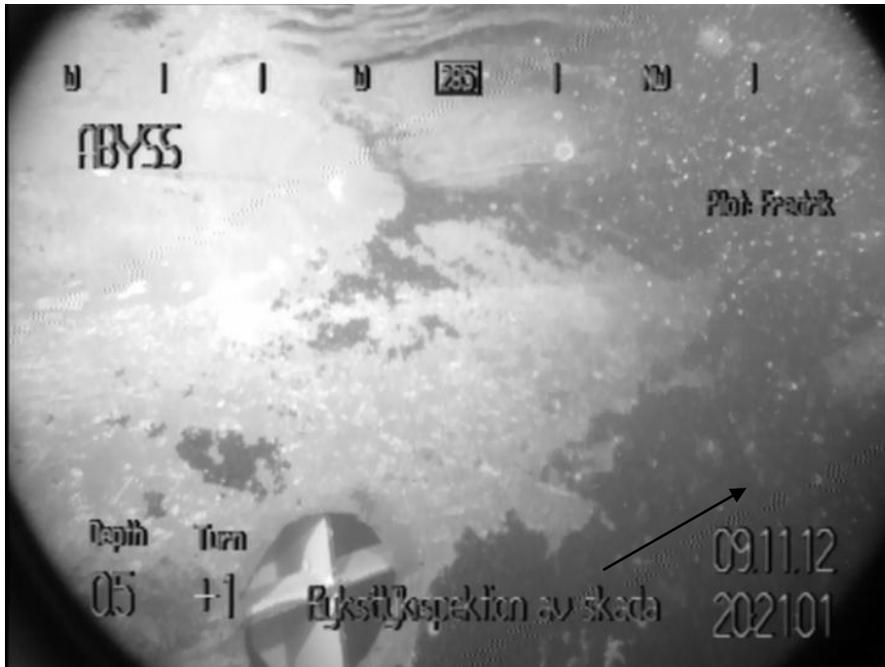
Figure 34: Scrape marks on the hull between anchor positions 8 and 7. Note that the lower brace for the bolster at anchor 7 can be discerned at the far right (see the arrow). The still photograph is from the ROV inspection film taken on 19 November 2012 [148].

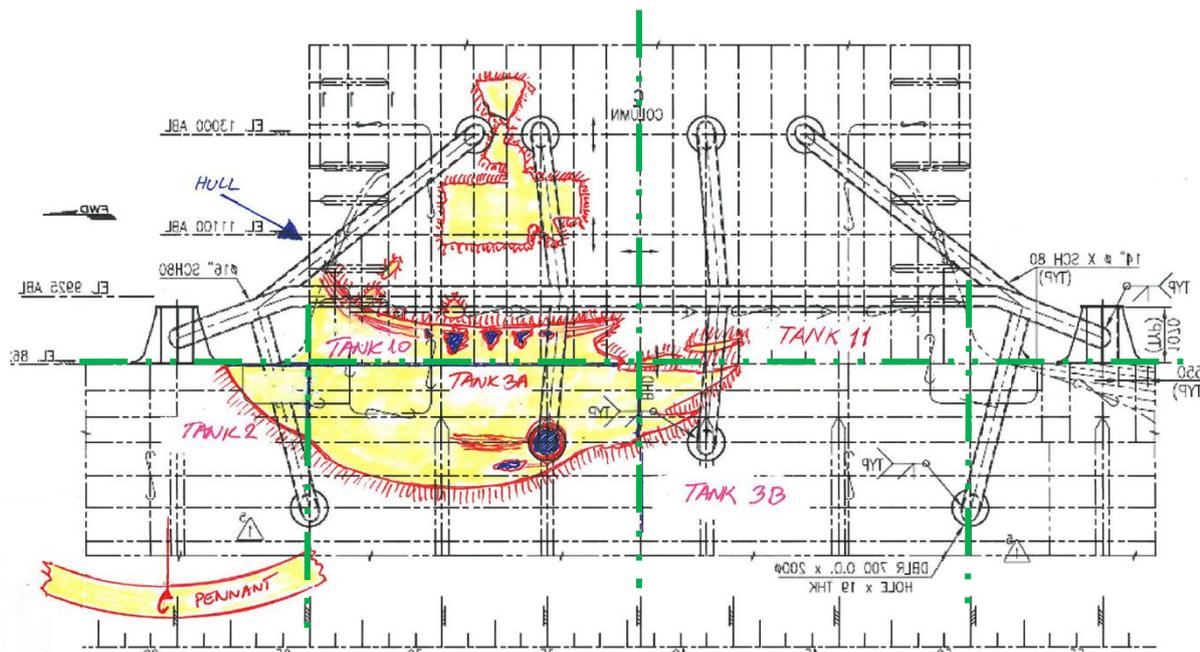
Figure 35: Detail of drawing with areas of the hull sketched in where mussels were scraped away by the anchor and the damaged pennant wire holder. These are marked in yellow. Seven of the eight holes in the hull are marked in blue. The eighth was on the front of the column close to the 11 100 millimetre level (see arrow). Note that the drawing has been reversed from a typical detail design to show the damaged area correctly. Scratch marks are found on the outside of tanks 2, 3A, 3B and 10 and small marks on tank 11. The total ballast weight for these five tanks is 1 500 tonnes. The boundaries between the tanks are shown by dotted green lines. Keppel Fels design drawing [58] with our markings in red, blue, yellow and green.

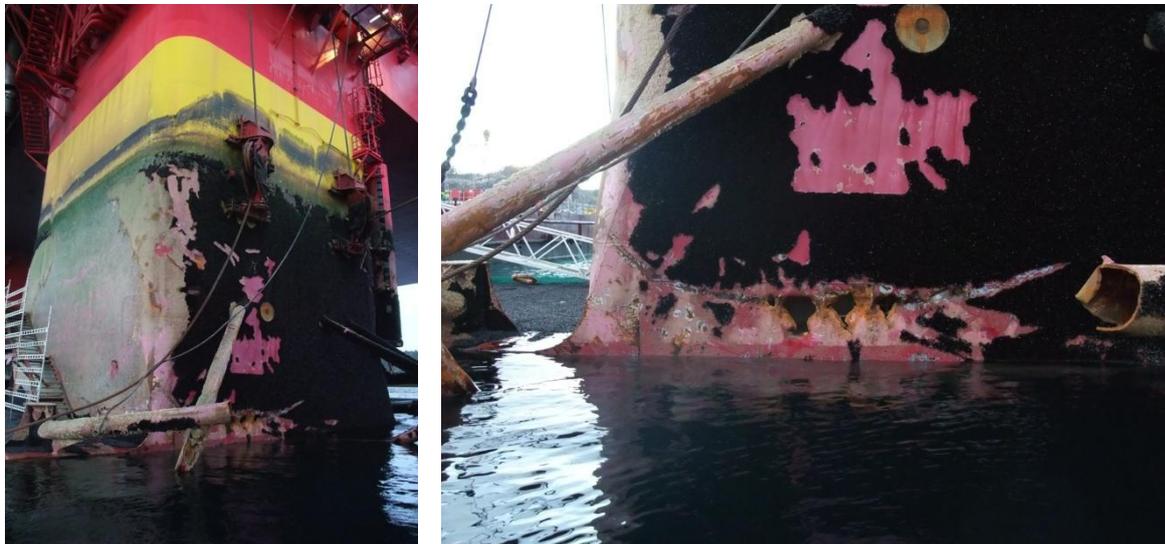
Figure 36: Damage above transit draft, with five holes in the hull side and one on the front of the column. All six were caused by penetration from the anchor fluke's points. Note that the areas where the anchor and the wire rope have moved are clearly delineated (red areas) by scraping away mussels (black area). The photographs were taken in Kristiansund on 12 November 2012 by the PSA.

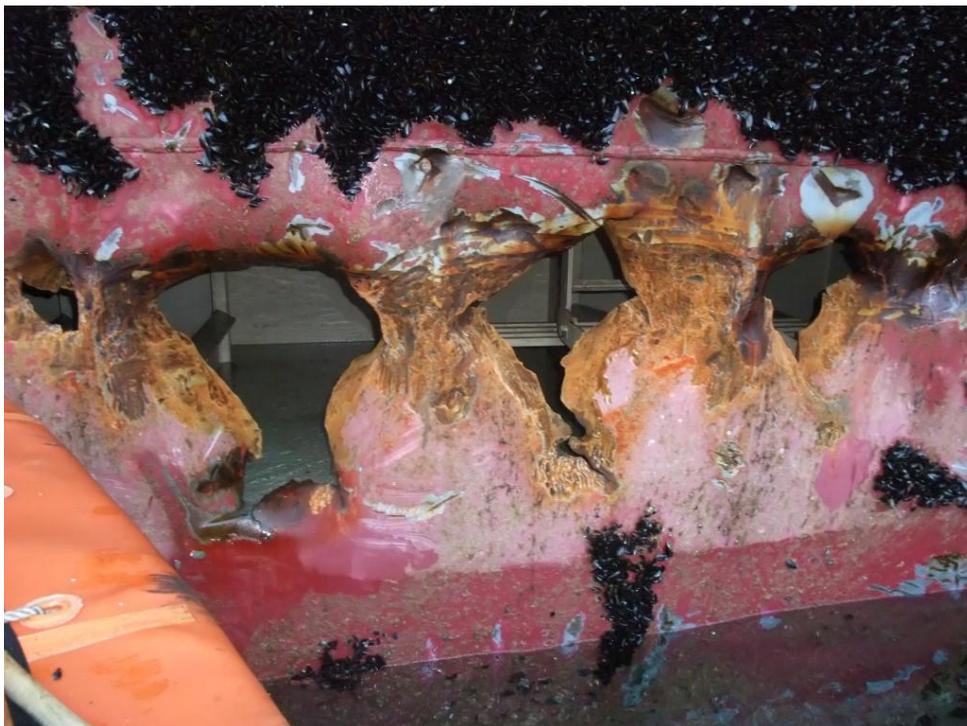
Figure 37: Five holes through the hull into tank 10. Note the clear marks from repeated blows. The hull between the hole is stiffened on the inside of the tank, and these stiffeners (about 0.6 metres apart) have absorbed the anchor's blows and prevented deeper intrusion to the tank's inner bulkhead (1.5 metres in). The photograph was taken in Kristiansund on 12 November 2012 by the PSA..

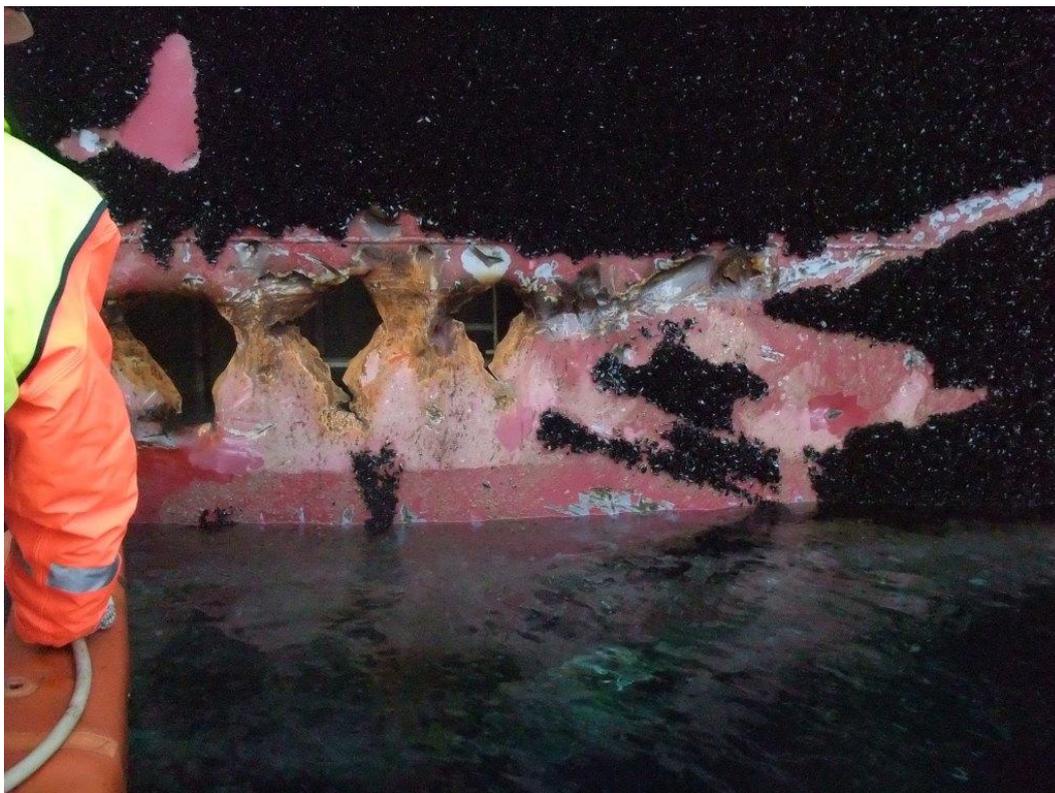
Figure 38: The holes and remaining mussel growth (black). The slanted scratches caused by the flukes towards the upper right provide clear signs of the anchor's pendulum motion. The photograph was taken in Kristiansund on 12 November 2012 by the PSA.

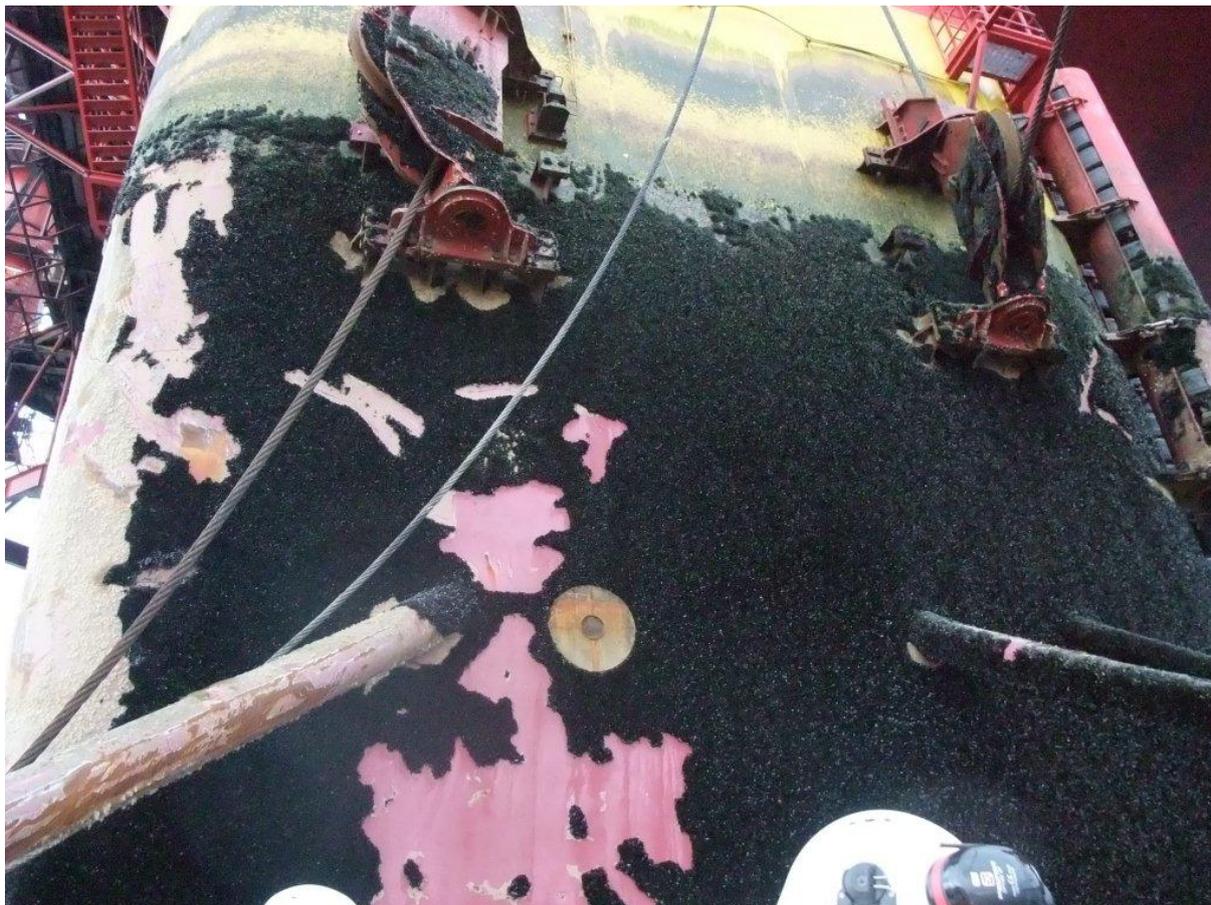
Figure 39: Bolster damage D, see Figure 27. The circular mark in the centre of the picture is where the brace was torn off with the doubling plate welded to the skin of the facility. Note that the doubling plate has been welded both around its exterior and in an inner ring (the plate was doughnut-shaped). The fracture has clearly propagated along the welds, and no noticeable bulging or plastic deformation has occurred on the hull plate, which indicates that this was not a ductile fracture. The internal stiffener cross can be observed, probably because welding heat during fabrication has penetrated the plate. Crack propagation in the doubling plate's weld to the hull rather than in the weld to the brace shows that the plate did not perform its intended role as a structural weak link. The mussels have not been scraped away around the doubling plate after it was ripped off, which is interpreted to mean that the anchor moved forward on the bolster at the same time, or possibly before. See also the scrape marks on the brace to the left of the photo. The photograph was taken in Kristiansund on 12 November 2012 by the PSA.

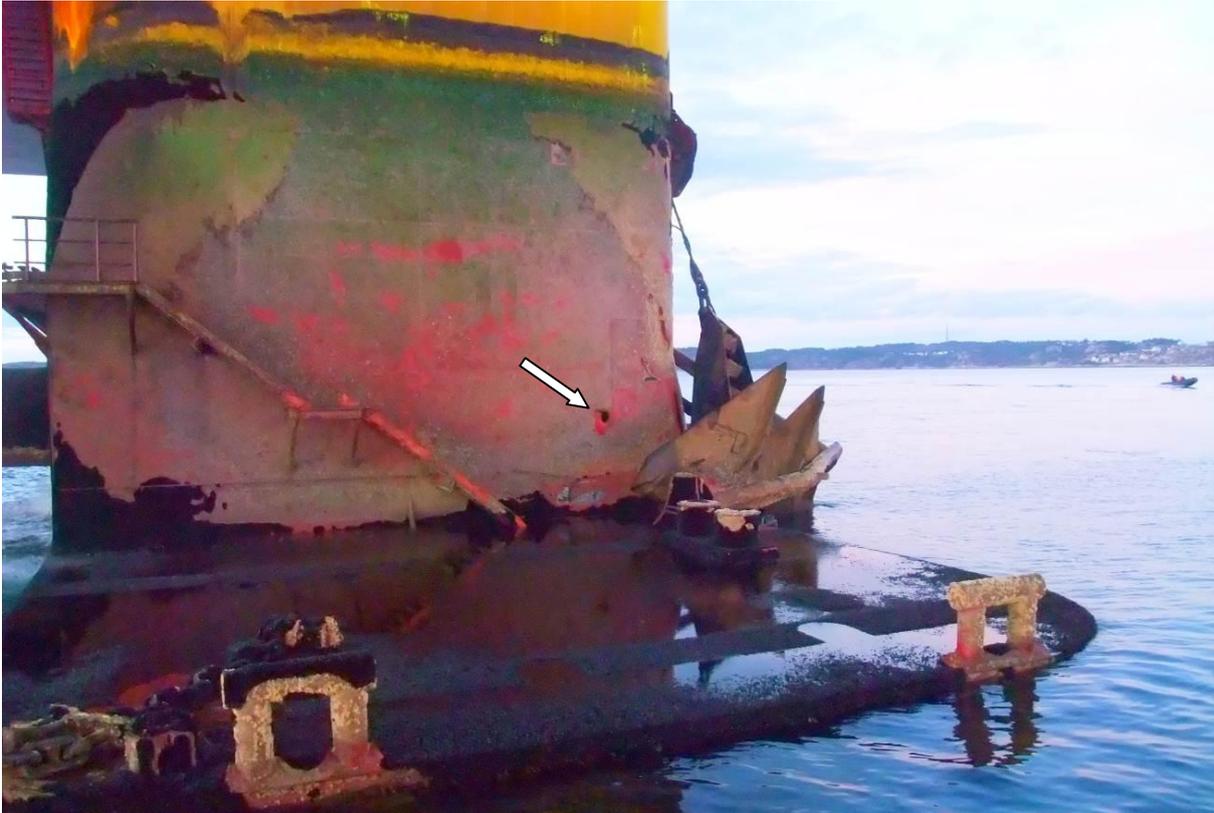
Figure 40: The forward port column on arrival in Kristiansund on 10 November 2012. Anchor 8 is wedged in the bolster and the hole into tank 10 (arrowed) is clearly visible. Some scrape marks at the bottom of the column show that the anchor has moved in the area. The pennant wire twined around the anchor line (above the anchor) shows that the anchor has rotated. The photograph was taken by the PSA.

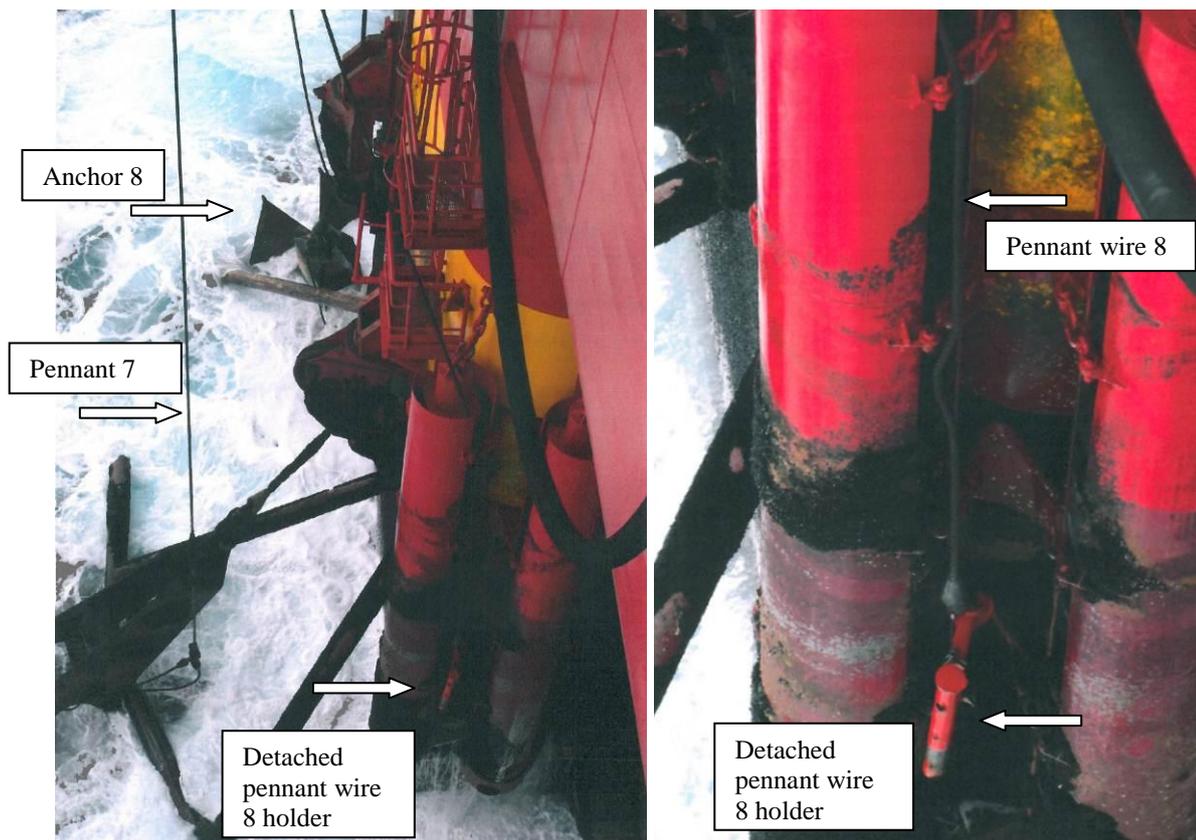
Figure 41: The pennant wire holder for anchor 8 after it had been torn free and damaged the railings and operating house. The overview photo on the left shows that the pennant wire must have become caught up in the railings or something else on a level with the anchor winch and drums (see Figure 42, where the positions are marked). The pennant wire hangs from a position above the top of the photo and down to the anchor, and also down to the damaged holder. The wire has apparently become wedged in the bumper¹¹⁴, and the terminal cable eye has come out of the holder. It appears to hang usually with a security lashing, which the crew reported was normal in order to secure the end of the pennant wire. The photograph was taken by Floatel International personnel on board during the incident day on 7 November.
