Investigation report

Report title Report from the investigation of the listing of <i>Floatel Superior</i> , 7 November 2012 on the Njord field	Activity number 420001003
---	------------------------------

An unsecured anchor caused water intrusion in two tanks on *Floatel Superior* during the night of 6-7 November 2012, leading to a list of 5.8°. The extent of the damage and the potential consequences of further water intrusion then prompted a decision to evacuate. The evacuation of 336 people was carried out by helicopter. None of the 374 people on *Floatel Superior* suffered any personal injury as a result of the incident.

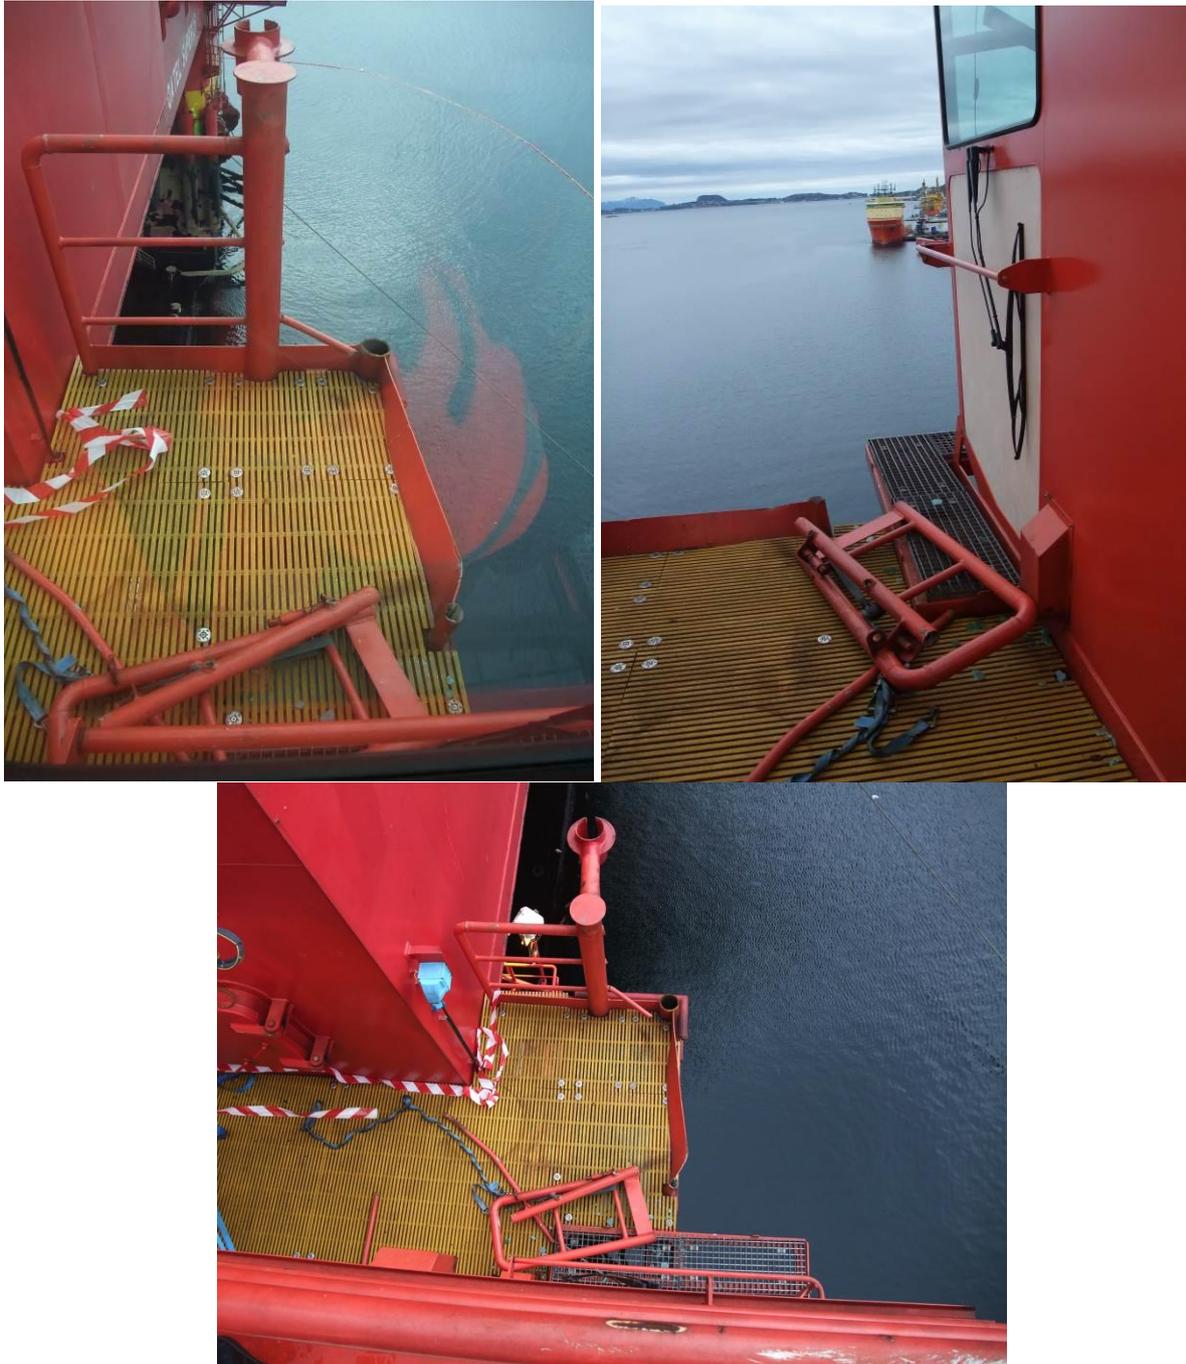
Figure 43: The area by the operating house where the pennant wire destroyed its holder, the railings and the operating house window. The damaged window is covered here with a wooden sheet. The holder for pennant wire 7 remains. The photographs were taken in Kristiansund in November 2012 by the PSA..

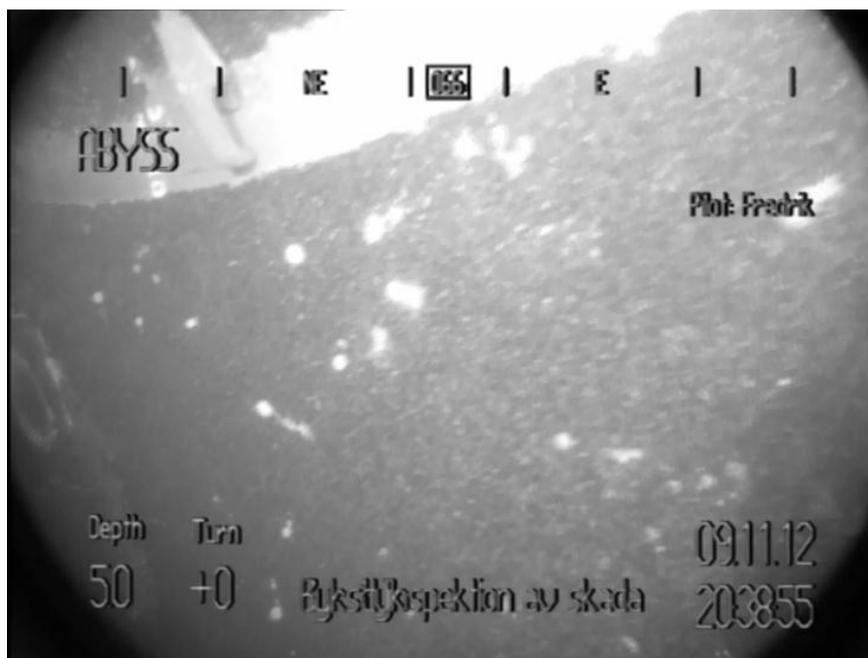
Figure 44: Still from the ROV inspection film of 9 November 2012 [148]. The damaged part of the cock's foot for attaching the pennant wire to anchor 8 can be seen at the top. The cock's foot hung down from anchor 8 after the incident. The cable eye is broken, probably because of a blow or a skewed or twisted load rather than wire tension. See location in Figure 27.

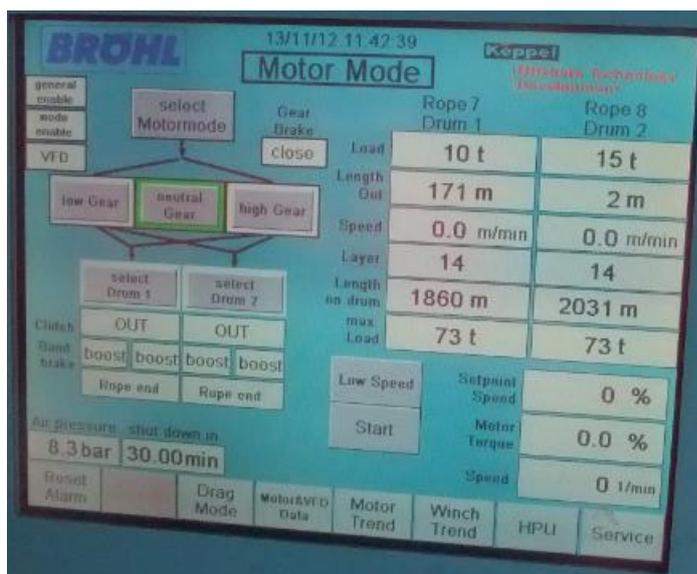
Figure 45: The control panel showing line tension on winch 4. Line 8 had 15 tonnes of tension after the anchor was taken off, which shows that the tension was erroneous. Line 7 seven was moored to land when the photograph was by the PSA in Kristiansund on 13 November 2012.

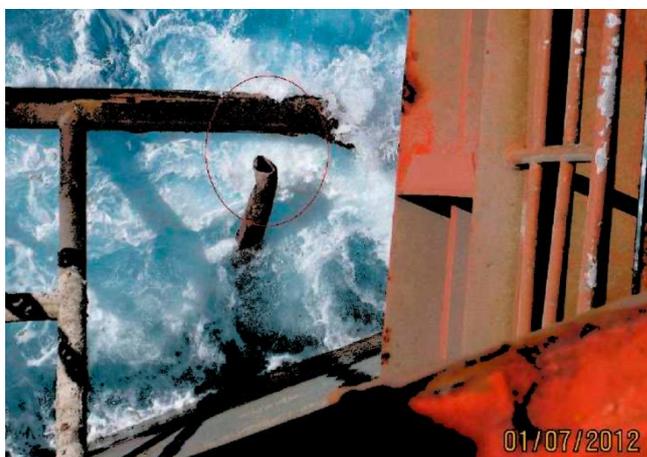
Figure 46: Brace cut off on the bolster on *West Hercules* 1 July 2012. Photograph: Seadrill [128].
