# Failures of offshore mooring steel wire ropes

Arne Kvitrud, Sigmund Andreassen and Marita Halsne  
Petroleum Safety Authority Norway (PSA)  
Stavanger, Norway

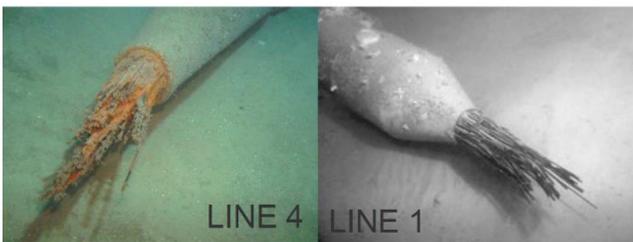
All the failed wires in the outer layers showed ductile overload. Both lines showed global bending or permanent plastic deformation in one direction. This indicated that the failures did not occur in pure tension loads. The visible failure surfaces were of the types "cup and cone", 45 degrees shear and in addition much "topography and lamination". This is typical to pure tension overload failures and with significant plastic elongation and reduced area in the failure zone. Post damaged tests of wires in pure tension showed the same characteristics. The tendency to 45 degrees is typical for both ductile overload and shear failures (Statoil, 5.7.2011).

Figure 3: The failed areas of the ropes at Navion Saga (Statoil, 17. 2012).

Statoil concluded in 2011 that the direct cause was ductile overload of the steel wire rope strands at the rope termination on the seabed, resulting from high local dynamic "snapping" loads after the line had temporarily gone slack. The ductile failures were of the "cup and cone" type. The remaining wires had been deformed permanently (Statoil, 28.9.2011).

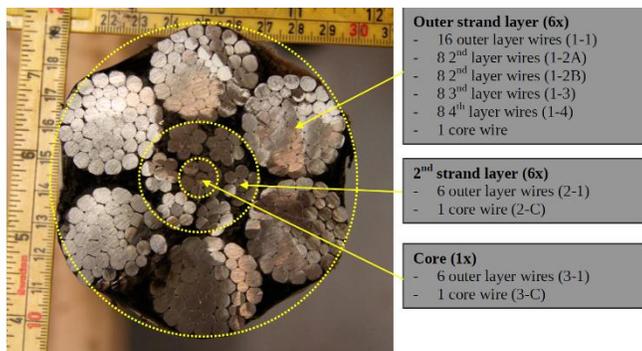
Figure 5: Geometry of one of the ropes after the failure (DNV, 12.3.2012). The strands seem to be partly disconnected to each other on the left side of the picture. This might have been a post failure damage.

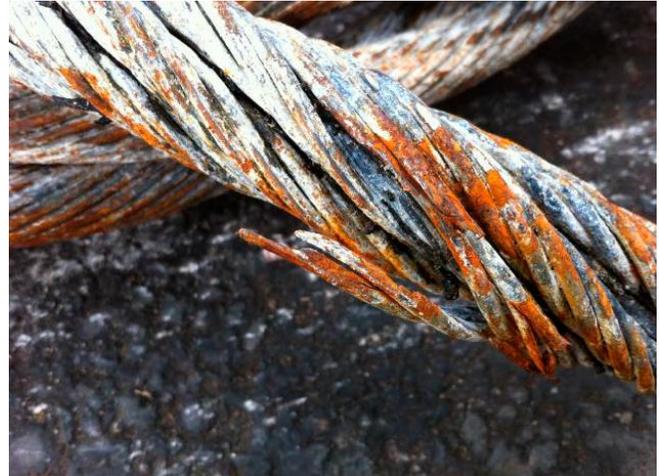
Figure 6: Representative picture of failed single wires, and on corrosion on a strand after two years in use (DNV, 11.3.2012).

The lubrication was mostly dried up, and small amounts of corrosion was observed. The strands showed signs of wear and deformations. The corrosion appeared in local areas with wear or deformations probably caused by the zinc wearing off. Single wire failures were especially where the single wires of one layer crossed the next layer. The rope had significant amounts of sand and corrosion products. The sand could be a post-damage consequence. The core strand contained a noticeable number of single wire failures. The single failures observed in the core showed failure surfaces angled at about 45 degrees. This is often associated with tensile overload or fatigue (DNV, 11.3.2012). According to Statoil (5.7.2011) the tendency to 45 degrees is typical for ductile overload and shear failures. The mechanical testing showed compliance with the DNV requirements (DNV, 11.3.2012). DNV (11.3.2012) concluded that the failures were probably caused by overload.

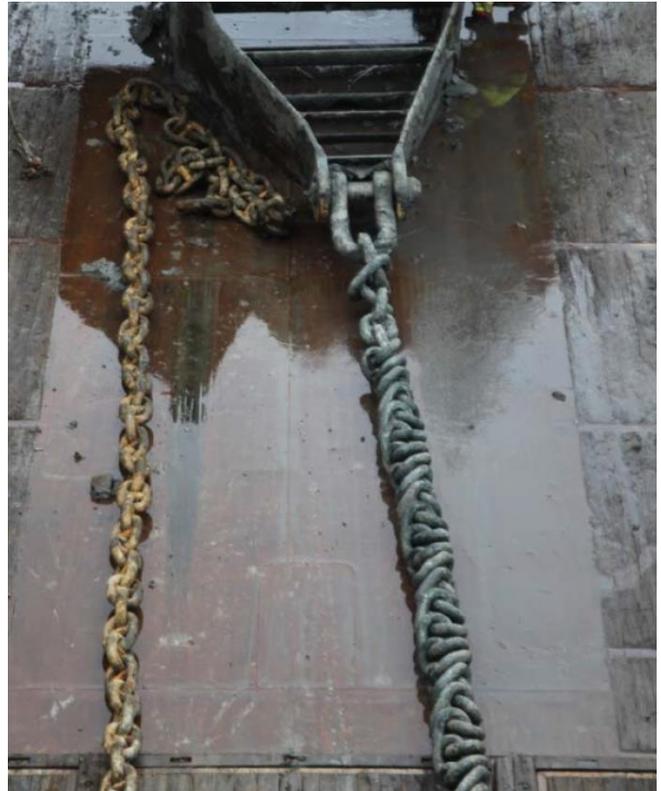
Ridge and Hobbs (2012) reported cases where the twist in steel wire ropes used during installation caused stored twist in a bottom chains.

Figure 8: Twisted chain accumulated in a bottom chain during recovery using a six-strand wire rope (Ridge and Hobbs, 2012 and Norland et al, 2012).

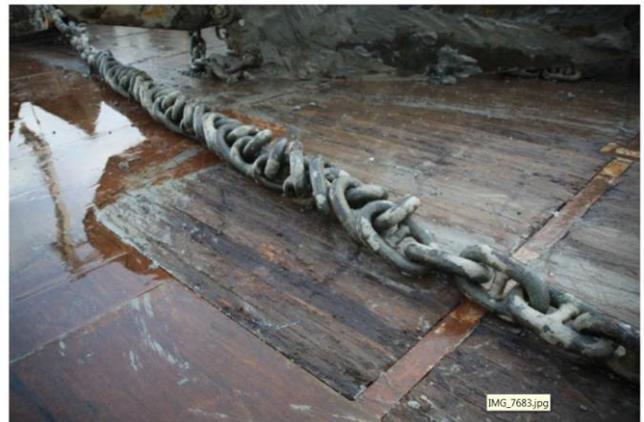
Figure 9: Twisted chain on the deck of an anchor handler vessel (Norland et al, 2012).

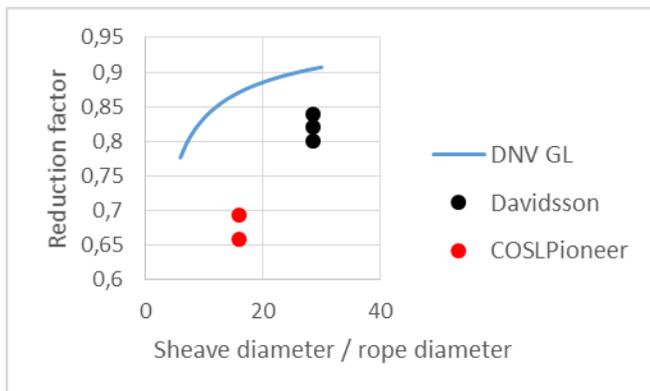
Figure 10: The DNV GL formula, the Davidsson (1955) results and the COSLPioneer data points from 2012. The COSLPioneer steel wire rope had lack of lubrication, wear and corrosion. A possibility that the measured load is too low is also present.

A much higher strength reduction factor might partly explain the COSLPioneer failures. Some suppliers recommend larger sheaves for rotation balanced steel wire ropes, because they are stiffer than stranded ropes.

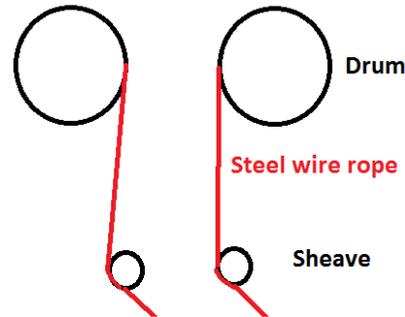
Bending of the wire ropes over sheaves should be as in the next figure (right). However, the industry practice is to do it the opposite way (left figure). The bending in opposite directions can be detrimental for the steel wires, especially in fatigue.

Figure 11: Good (right) and not so good bending directions (typical for offshore steel wire ropes) over sheaves. The geometry affect fatigue (Verreet, 2002), but the bending geometry might also reduce the general condition of the rope.
