**Proceedings of the ASME 2018 37th International Conference on
Ocean, Offshore and Arctic Engineering
OMAE2018
June 17-22, 2018, Madrid, Spain**

OMAE2018-77008

OBSERVED WAVE ACTIONS ON NORWEGIAN SEMI-SUBMERSIBLE AND TLP DECKS

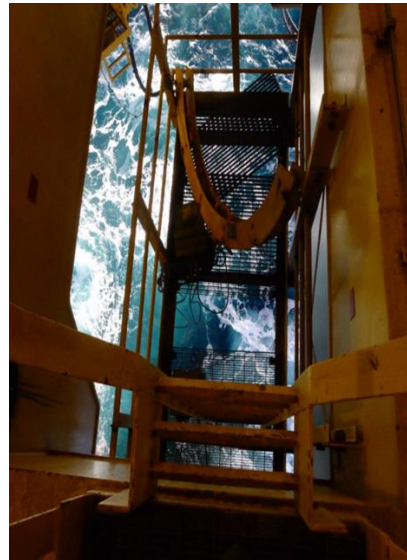
FIGURE 1: THE GAP IN THE GRATING ON THE BOP CARRIER PLATFORM WHICH THE PERSON FELL THROUGH ON SCARABEO 8 (PSA, 2015).

20 February 2015 a man fell overboard from Scarabeo 8. At the time of the incident, two engineers were working in the moonpool area. One of the engineers descended the ladder to a small access platform. As he stepped off the ladder onto the grating below, he fell through a gap directly into the sea 13.5m below. The man was rescued, without serious physical injuries. The exact moment when the grating disappeared is uncertain. The site of this incident is unlikely to have been in use since 6 February 2015. Scarabeo 8 was exposed to rough weather in the two weeks leading up to the incident (Eni, 16.3.2015 and PSA, 14.4.2015).

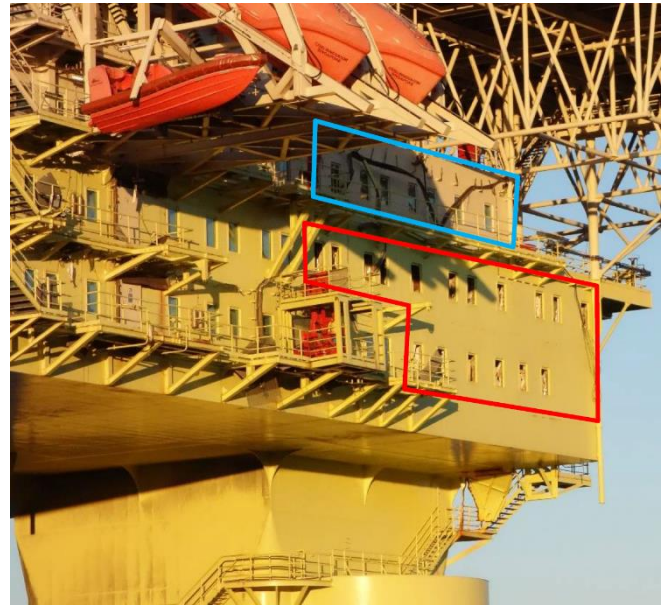
FIGURE 2: FORWARD BULKHEAD OF THE COSLINNOVATOR AT CCB AFTER THE INCIDENT (PSA, 2016). THE RED AREA HAD DAMAGES FROM THE WAVE MOVING HORIZONTALLY. THE BLUE AREA HAD DAMAGES FROM THE WAVE MOVING UPWARDS.

COSLInnovator suffered extensive damage to 17 cabins as well as corridors spread over two decks forward on the port side. Six windows on the lower deck and eleven on the mezzanine deck were forced inwards. The injured had been in their cabins. Above the main deck level, damages to grating panels, cable trays and secondary structures were directed upwards, indicating a run-up effect.

Towards the centre of the box girder's forward face and above deck A-level, damage to glass, grating panels, weathertight doors, cable trays, equipment cabinets and so forth was on a smaller scale and oriented in various directions – both inwards at the midships doors and upwards in the area by the helideck.

Estimates for horizontal pressure from the slamming wave on the windows were from different parties estimated by Stansberg (2016) as 200 – 300kPa, Wood Group (2016) 250 – 300kPa (based on deformed bulkhead plates and stiffeners) and DNV GL 350kPa (PSA, 2016). The failed window frame bolts could take up to 180kPa.
