MODIFICATIONS OF THE PSA REGULATIONS BASED ON CASE STUDIES OF STABILITY ACCIDENTS

Arne Kvitrud

Petroleum Safety Authority Norway (PSA)
Professor Olav Hanssens vei 10
NO-4003 Stavanger, Norway

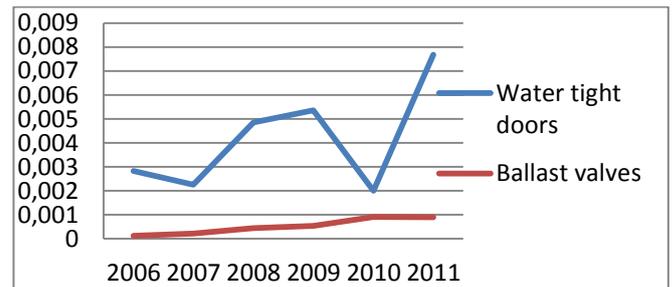
The number of errors in ballast valves has steadily increased in recent years (Figure 1). Variability from year to year is greater for watertight doors, but the overall failure rate has risen. We have also compared age and failure rates. Units have been divided into four age groups: 1976-1983, 1984-1990, 1991-2003 and 2004-2011. The number of units in each group is about the same. As Figure 2 shows, the youngest units have the most errors. The increase in the failure rate over the past few years mainly reflects a large number of new units with many errors.

Figure 1: The number of errors on mobile units divided by the number of function tests on watertight doors and valves in ballast systems as a function of fabrication year.

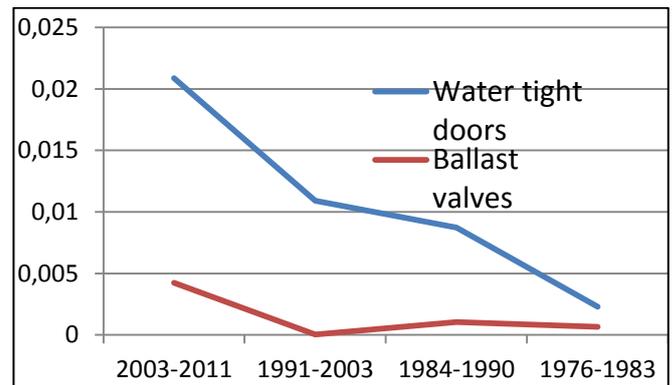
Figure 2: The number of errors divided by the number of function tests of watertight doors and vents in ballast systems as a function of fabrication year.
