Investigation report

Report title Report from the investigation of the listing of <i>Floatel Superior</i> , 7 November 2012 on the Njord field	Activity number 420001003
---	------------------------------

An unsecured anchor caused water intrusion in two tanks on *Floatel Superior* during the night of 6-7 November 2012, leading to a list of 5.8°. The extent of the damage and the potential consequences of further water intrusion then prompted a decision to evacuate. The evacuation of 336 people was carried out by helicopter. None of the 374 people on *Floatel Superior* suffered any personal injury as a result of the incident.

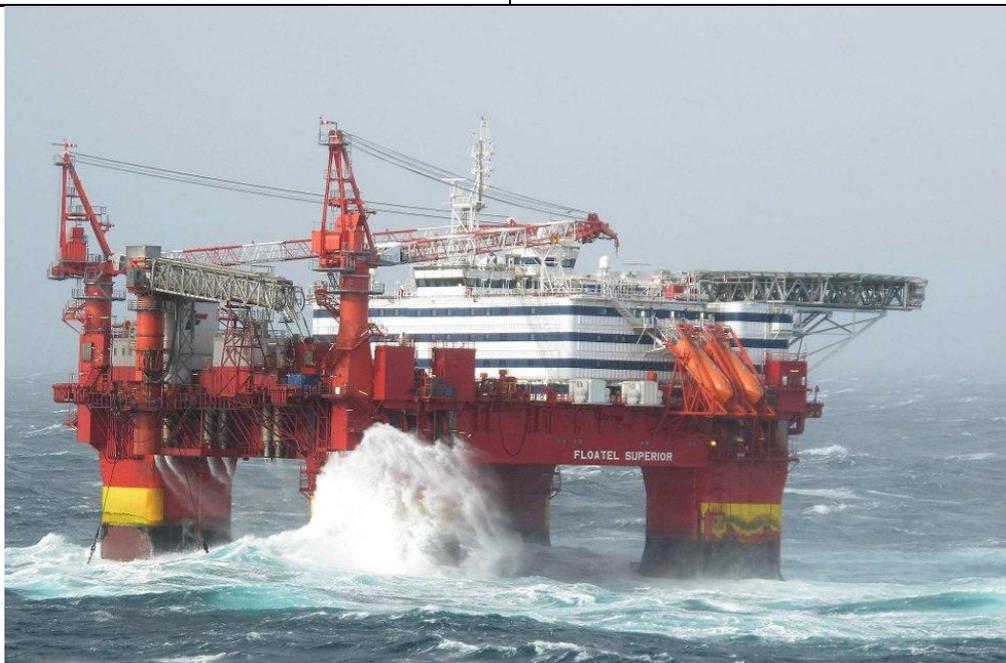
Figure 1: *Floatel Superior* at survival draft (13 metres). The air gap is 14.5 metres from sea level to the underside of the topside (beneath the text “FLOATEL SUPERIOR” in the photograph). Spray from the wave in the foreground reaches the drum of winch 4 (with anchor line 8) on the forward port column. The photograph was taken during an earlier episode of bad weather. Copyright Erik Sevaldsen¹.

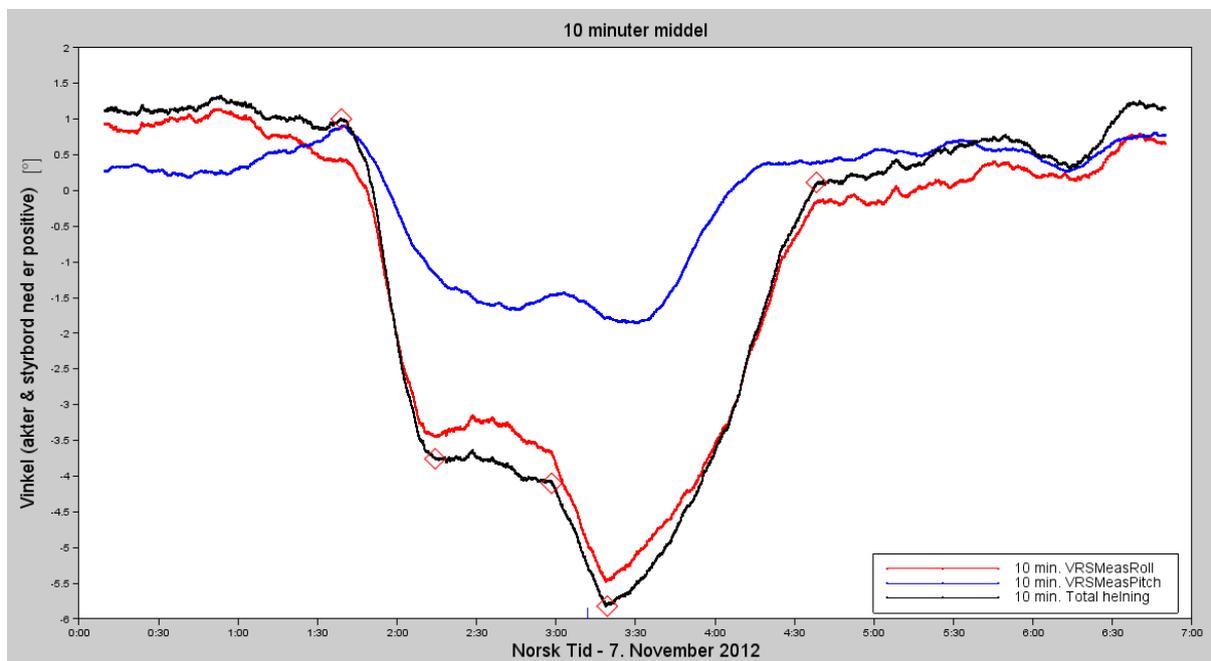
Figure 9: Calculated mean listing history from measured roll and pitch motions on the incident night. The diamond symbols mark the times when clear changes occur in the graphs – about 01.40, 02.15, 03.00, 03.20 and 04.40. These incidents and times are discussed in the text. The figure has been produced by the PSA on the basis of data files from Floatel International [56 and 57].

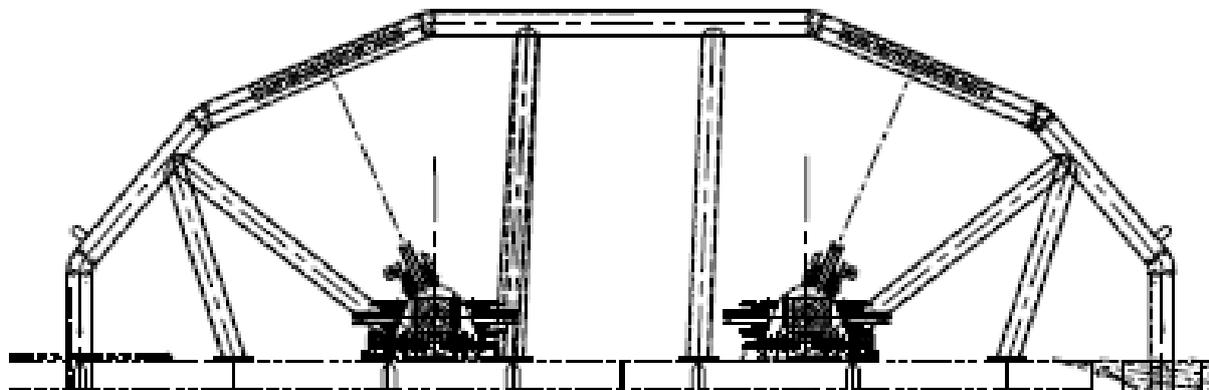
An anchor bolster lost three braces on the night of the incident as a result of damage which had occurred and developed over time. After these had fractured, the remaining bolster components were unable to prevent the anchor from hitting the hull directly. The anchor was left hanging free, struck the hull repeatedly during heavy seas, and made seven holes. The final hole was created when a damaged part of the bolster suffered a fatigue fracture.

Figure 11: A drawing of the bolster on *Floatel Superior* produced by Keppel Fels [58]. It consists of 14- and 16-inch steel tubes welded together. The anchors are attached to the wear surfaces identified by black infill. The dotted lines show the wire ropes from the winches to the anchors. The latter are not shown, but their intended positions are indicated by the wire ropes. Anchor position 8 is on the right-hand side of the figure and 7 to the left. See also Figure 12, which shows the same bolster after the damage.

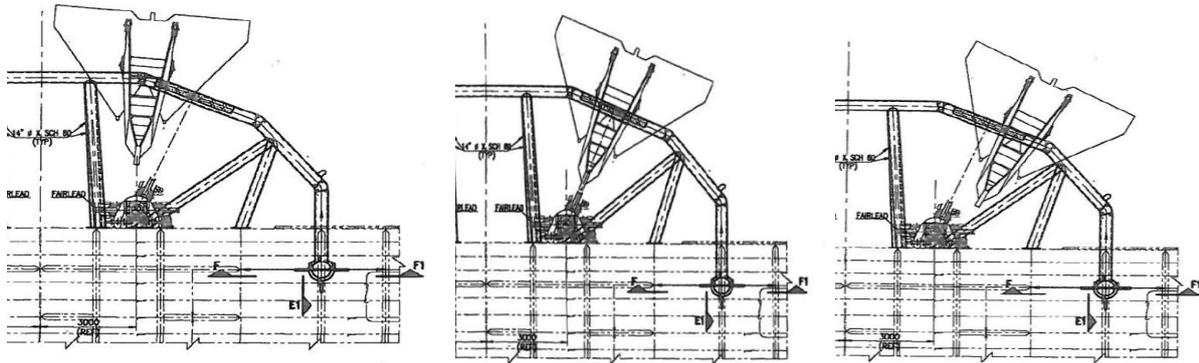
Figure 14: Drawing of the anchor positions: Centre: correctly stowed in contact with the wear surface on the bolster and with a short line (about 22 metres⁴⁷). Left: against the bolster's aft brace. Right: against the forward brace. The bolster section intended to hold the anchor is roughly right-angled at the shortest distance from fairlead to hull side under the fairlead (centred). If displaced in the order of one metre to either side, the contact points on the anchor reach the bend on the bolster and mean that the line is lengthened by about 50 millimetres⁴⁸. That causes the active part of the wire to be elongated by $50/22000 = 0.3$ per cent. Our estimate for the increase in line tension to reach this geometry is 44-63 tonnes⁴⁹.

Keppel Fels has subsequently calculated⁵⁰ that, when the anchor moved from its intended position and onto the brace, the line must have elongated by the equivalent of 44 tonnes of tension. That is substantially larger than the load applied by Keppel Fels in its wave analyses.

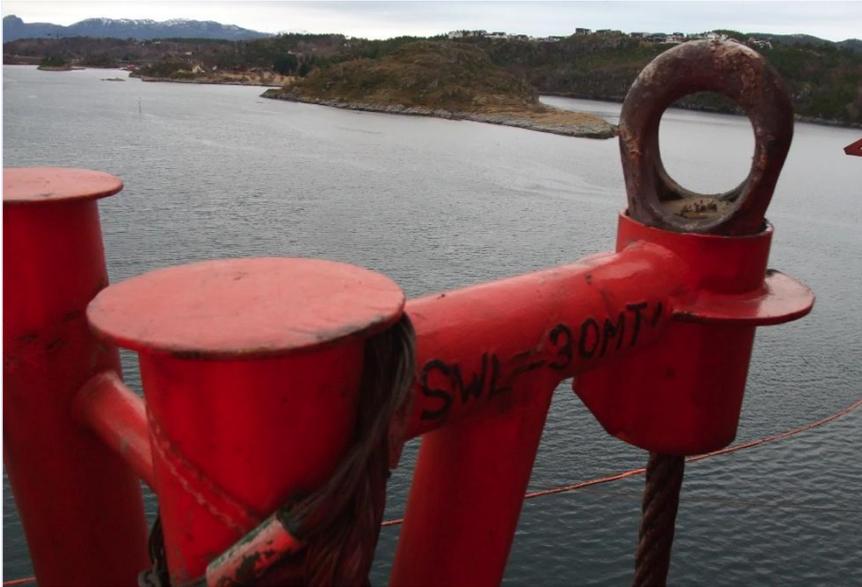
The wire holder was designed in such a way that a fracture would cause damage to railings and cabin, which must be well protected pursuant to the regulations. No weak link or other safety device could have isolated the damage and reduced the damage potential. Similar damage could have been caused by a possible emergency release of the anchors from their stowed position (in the bolster with the pennant wire in the holder).

No solution is available to ensure that consequential damage from uncontrolled anchor deployments or displacements will be limited.

Figure 15: An intact pennant-wire holder on *Floatel Superior*. The wire is freed by lifting the loop away from the hull with a crane. The whole steel structure for wire 8 was ripped off, including holder and railing. The photograph was taken by the PSA in Kristiansund on 13 November 2012.

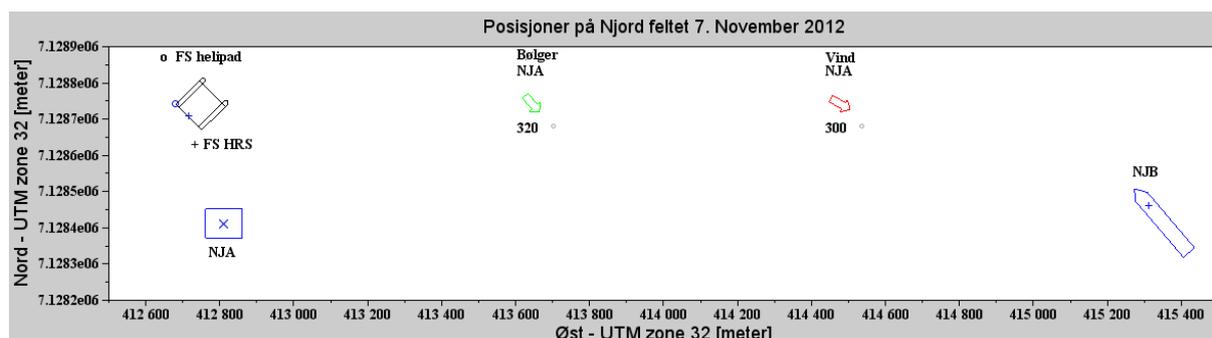
Analyses by the joint rescue coordination centre (JRCC) around 20.00 on 7 November showed a 50 per cent chance of colliding with Njord A with free drift [132]. The centre conveyed this to Statoil, but the information was not passed satisfactorily to Njord A or *Floatel Superior* [139]. If the emergency response management on *Floatel Superior* or Njord A had received this information, they could have given the *Floatel Superior* crew a better basis for assessing the facility's position. Statoil [139] maintained that, had this information been received on Njord A, it would have demanded that *Floatel Superior* be moved to another position without a collision risk.

Figure 16: Position of the facilities on the incident day, 7 November, with wind and wave directions. The arrows point in the direction of the weather. The coordinates for Njord A (NJA) and B (NJB) are from the Sisu database. Those for *Floatel Superior* labelled as *FS helipad* (indicated by 0) are from the video during the evacuation,⁶⁹ and the point marked *FS HRS* (indicated by +) are the coordinates specified by the JRCC at 03.59 on 7 November 2012. We have positioned *Floatel Superior* in relation to these two positions. The coordinates have been transformed to UTM zone 32 by the NPD.

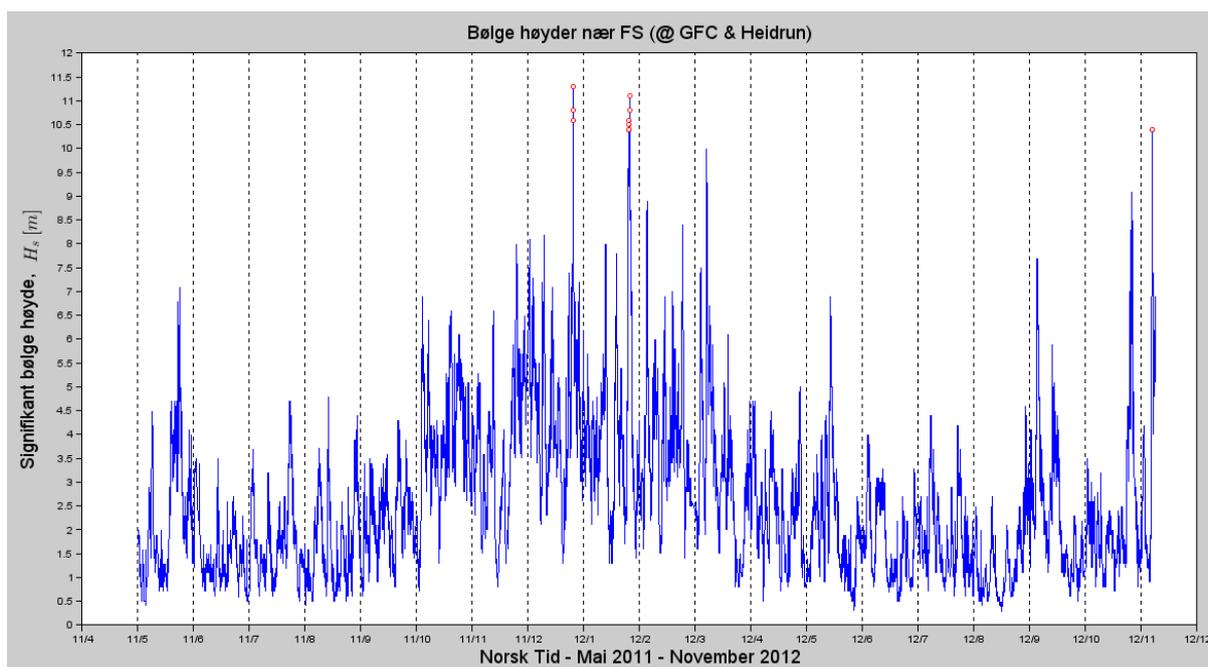
Figure 18: Wave conditions in locations close to *Floater Superior* when operating on the NCS (measurements from Gullfaks C from 1 May-31 July 2011 and Heidrun from 1 August 2011-8 November 2012). The weather on 7 November was registered as Hs 10.4 metres at 00.00 and 01.00 (on Heidrun). *Floater Superior* has only experienced worse seas in two previous storms: 25 December 2011 with maximum Hs = 11.3 metres and 26 January 2012 with maximum Hs = 11.1 metres. Observations of Hs = 10.4 metres and above are marked with red circles. Information from Statoil [124].

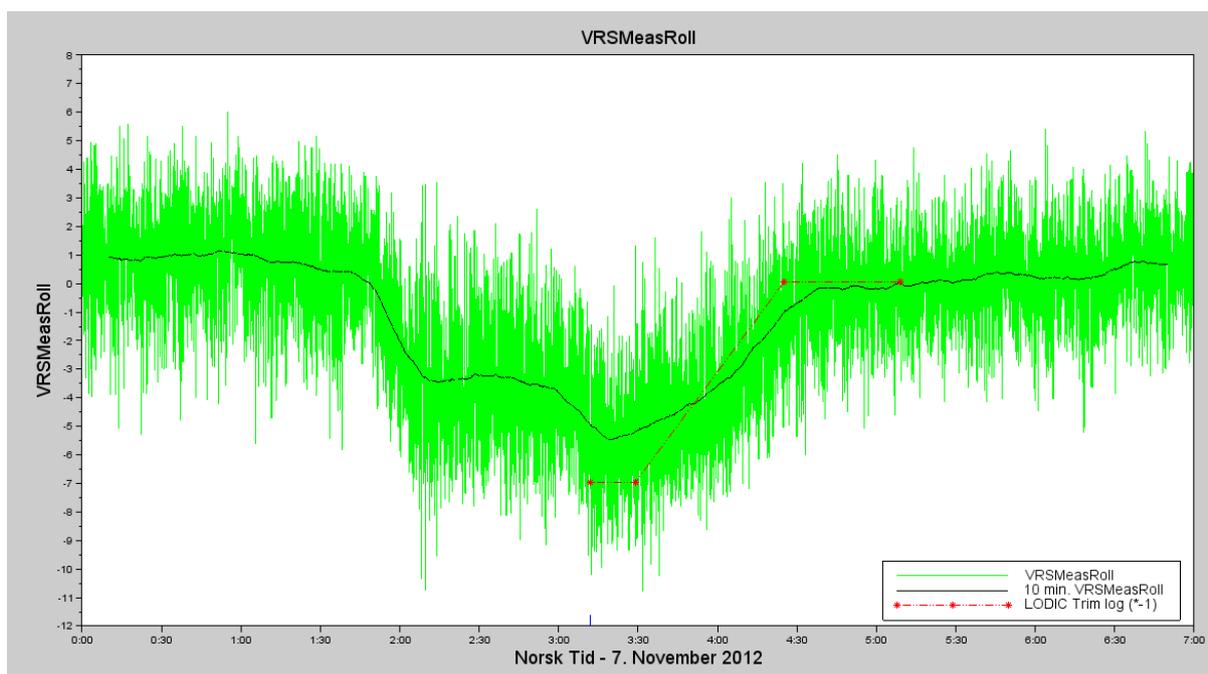
Crew on the bridge had access to the stability computer on the incident night, and documented the position before and after deballasting through printouts. It was stated in a number of post-incident conversations that the facility rolled before and during the incident. This observation is supported by data logging in the VRS, where Figure 20 clearly shows a higher mean angle

Figure 20: Registered roll on *Floatel Superior* in degrees. The horizontal axis shows Norwegian clock time from 00.00 on 7 November. The vertical axis shows roll (port down) in degrees. Red stars show trim from the stability programme (with opposite sign) [12 and 13] at times specified in the DP event log [19]. The graph has been produced by the PSA on the basis of data files from Floatel International [56 and 57].

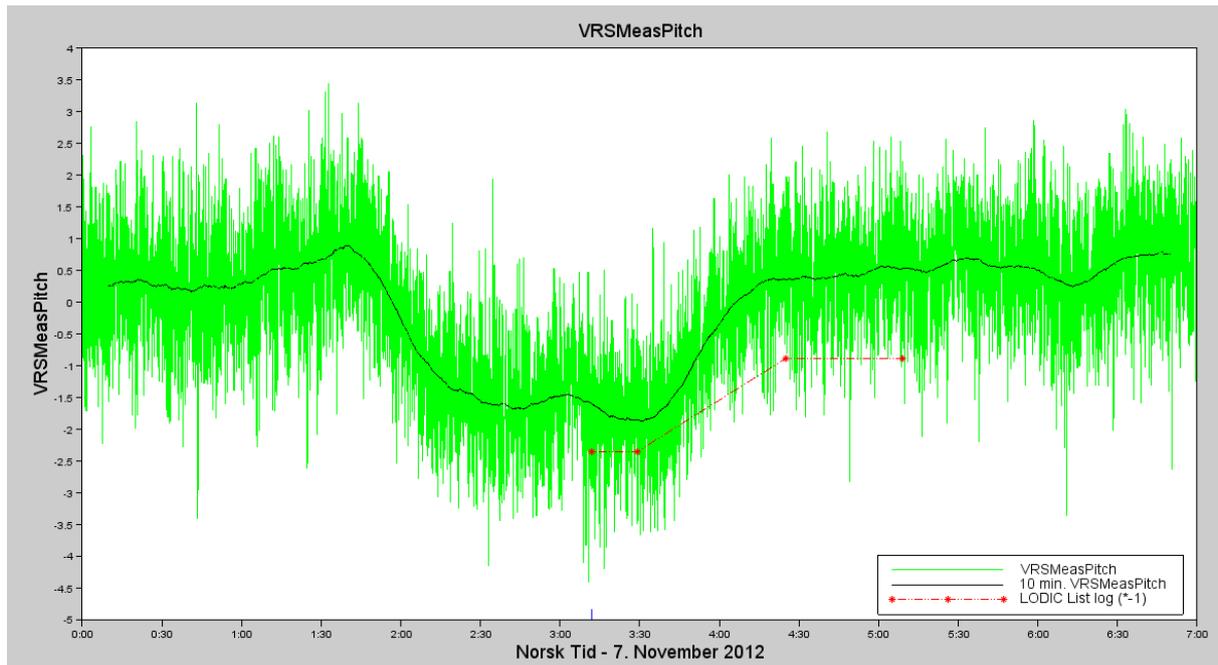
and larger reflection in terms of roll than is measured in the pitch direction and reproduced in Figure 21. The stability report before deballasting, at 03.29, specifies trim as $+6.959^\circ$ and list as $+2.345^\circ$ [12]. These values from the Lodic programme do not accord with the motions measured and described for the facility. An analysed condition which does not take account of the effect of wind load must be expected to show some discrepancy from the values actually measured. Note nevertheless that Figure 23 shows roll of about -5.0° and pitch of roughly -1.6° at the same point in time. The Lodic printout clearly shows the arithmetical sign applied. Real-time measurements stored in the VRS system have not defined directions, but applied the general notation which indicates that the measurements follow the definitions described in Figure 5. The fact that two available systems use opposite conventions for arithmetical signs could be unfortunate in circumstances where the right decision depends on clear information. Note further that the two systems appear to show the biggest motion in two different directions. This suggests that one of them is reporting inaccurately. That is corrected in the figures by presenting Lodic's trim values in the diagram for roll and its list values in the graph for pitch. According to a conversation with the programme developer at Lodic AS (part of Kongsberg Seatex after 1 January 2013), the Lodic system on *Floatel Superior* assumes that the facility operates with small inclination angles. Discrepancies because of the effect of level measurements in partly filled tanks and of wind pressure can cause inaccuracies in the analysed values⁸³. The Lodic system utilises tank level measurements from the Kongsberg Seatex system on board and is connected to sensors in accordance with the Kongsberg Seatex documentation⁸⁴. But the possibility of a faulty connection which swaps roll and pitch cannot be excluded without verifying the physical connections on board.

Figure 21: Registered pitch for *Floatel Superior* on the incident night. The horizontal axis shows Norwegian clock time on 7 November. The vertical axis shows pitch (bow down) in degrees. Red stars show list from the stability programme (with opposite sign) [12 and 13] at times specified in the DP event log [19]. The graph has been produced by the PSA on the basis of data files from Floatel International [56 and 57].

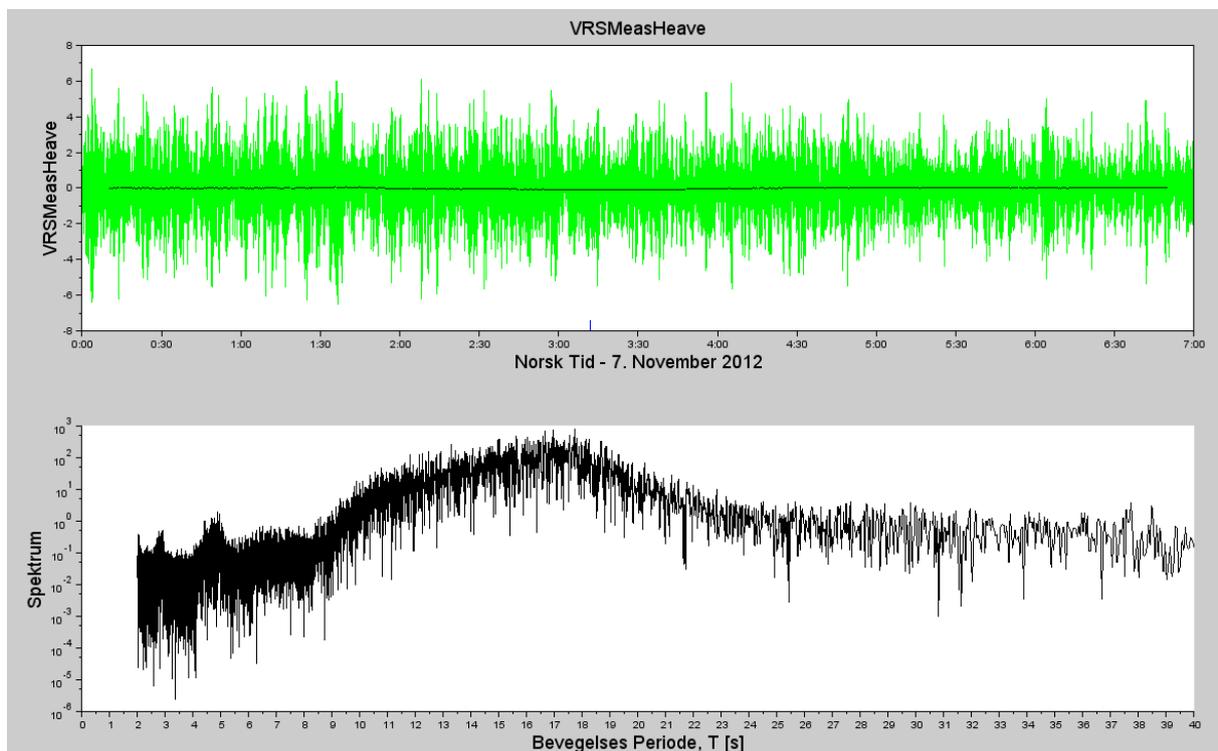
Figure 22: Registered heave for *Floatel Superior* on the incident night. The topmost graph shows the timeline. The horizontal axis shows Norwegian clock time on 7 November. The vertical axis shows heave and the 10-minute mean line. The graph above shows wave energy spectral density on a logarithmic scale as a function of the motion period. Note that motion in the 10-18 second interval is dominant, and at peak is at about the 17 second period in accordance with the weather information about Pp. The figure has been produced by the PSA on the basis of data files from Floatel International [56 and 57]. According to the marine operations manual [95], the natural period for roll and pitch for *Floatel Superior* lies between

48 and 77 seconds at drafts from 16.0-20.5 metres, and is thereby far outside first-order wave influences. The natural period for heave is given as 18.7-19.0 seconds, and is thereby very close to the dominant Pp on the incident night. Nevertheless, no clear spike can be seen in the spectrum which shows any marked dynamic amplification.

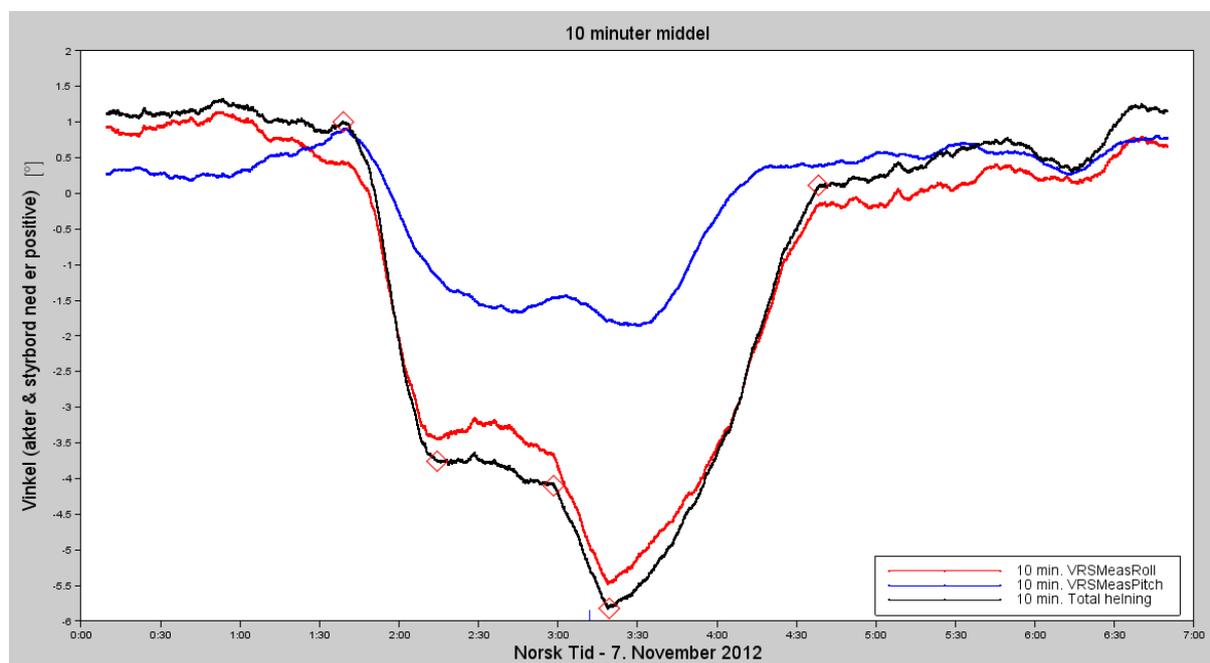
corresponding pitch, both measured in degrees. Ten-minute mean values are marked on both graphs, and ignore wave motion (10-18 second periods are typically recorded for heave). Figure 23 shows the overall list picture for the facility on the basis of the two sets of separate roll and pitch measurements. Four incident points are marked on the graph for mean list. In addition, the observation time at 03.12 is marked on the time axis. The graphs show a relatively stable facility from 00.00 to about 00.45. This is followed by a period of roughly an hour when a change occurs in the relationship between the facility's heading and its direction to the wind and waves⁷⁹. From having the weather to port, the heading altered to bring it closer to bows-on. This is shown by the fact that wind pressure caused a roll to starboard early in the period, and later pressed on the superstructure aft at around 01.40.

The deballasting which began after the crew discovered the problem is clearly visible on the list graph in Figure 23. Between 03.20-04.40, the facility was righted by 5.9° to roughly even keel -0.1° (4.4° per hour)⁸¹. Stability reports before and after deballasting show that the facility was lightened by a total of 464 tonnes, including 451 tonnes of ballast water.⁸² The latter comprised 226 tonnes from tank number 1 outer port, 115 tonnes from 5B outer port, 47 tonnes from 10 outer port (holed, but partly above water), 33 tonnes fra 2 outer starboard and 23 tonnes fra 3A outer starboard. In addition come several minor tank adjustments.

Figure 23: Calculated averaged list history from measured roll and pitch on the incident night⁸⁵. The diamond symbols mark times when clear changes occur in the graphs – about 01.40, 02.15, 03.00, 03.20 and 04.40. Incidents and times are discussed in the text. The figure has been produced by the PSA on the basis of data files from Floatel International [56 and 57].

It is emphasised that the crew, from the sounding of the bilge alarm at 03.12 until after deballasting (right up to 08.45), were convinced that only one tank had been damaged. Given the information presented above, it can be stated that tank 3A outer port was holed at 02.15. It was then virtually empty but according to the crew should have been full⁸⁶. The tank took on some 360 tonnes of^{87 and 88} over 45 minutes (eight tonnes per minute). See also chapter **Feil! Fant ikke referansekilden.** on measurements and alarms in the event over unintended tank filling.

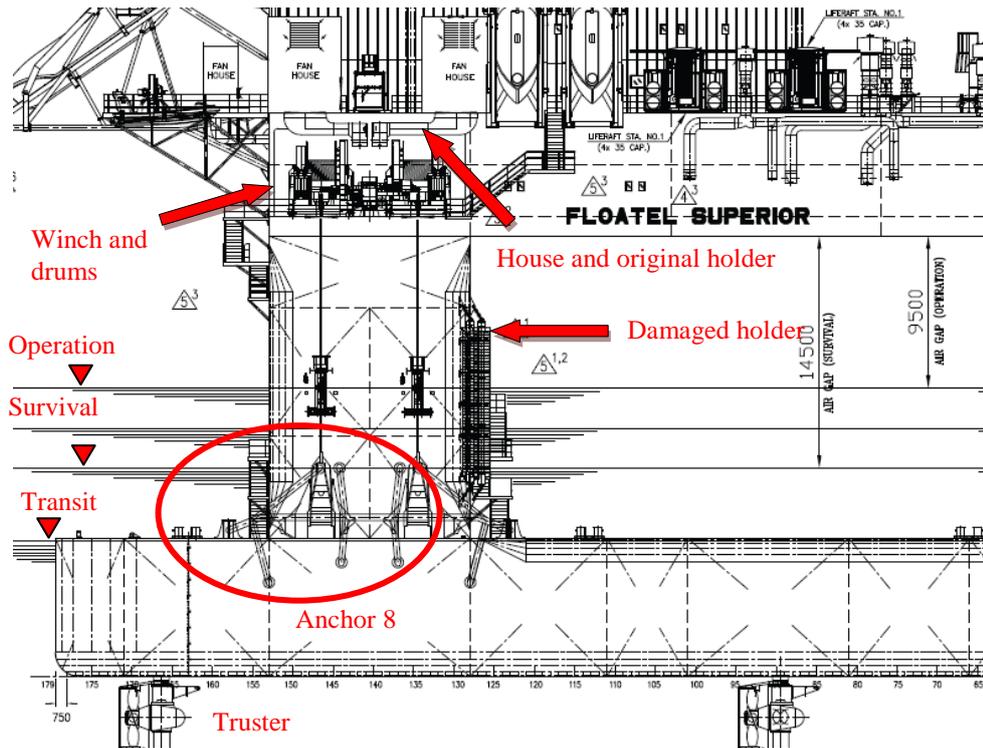
Figure 42: Detail from the side of *Floatel Superior* which shows the forward port column with anchor position 8 circled. The topmost arrow shows the operating house with railing where the pennant wire was positioned before the incident. The bottom arrow shows the final position where the ripped-off wire holder was found after the damage. At far left, the markings for operating (top – 18 metres), survival (centre – 13 metres) and transit (bottom – about 8.5 metres) draft are shown by red triangles. Two of the six thrusters are seen under the pontoon. If the pennant wire had not been caught up in the facility after being ripped from its holder, it could have hung 15-20 metres beneath the keel. That would have given it the potential to be drawn into the forward thruster on the port pontoon. The drawing shows anchors of another type and a different position in the bolsters than those which were actually installed. From Keppel Fels' drawing [58].
