# Failures of offshore mooring steel wire ropes

Arne Kvitrud, Sigmund Andreassen and Marita Halsne  
Petroleum Safety Authority Norway (PSA)  
Stavanger, Norway

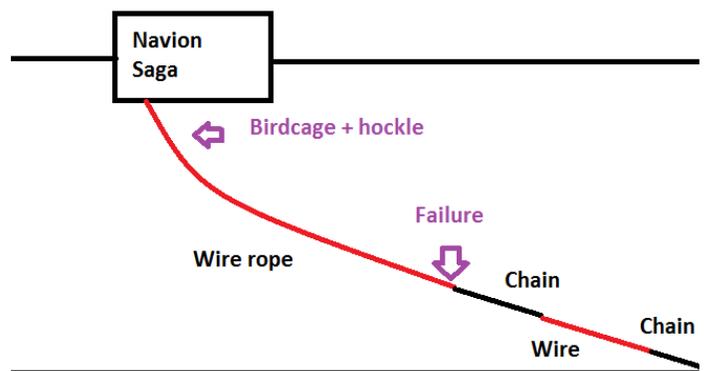
On 20.6.2011 two steel wire ropes on the Navion Saga FSO failed. The failures were on both lines located at the bottom end of the upper steel wire rope segment, at the bending stiffeners and the sockets. The failures probably took place on two different occasions in stormy weather, several months before the inspection. This conclusion relies on the degree of corrosion. No inspections of the line integrity were done from the installation until the failures were found (Statoil, 2.12.2011).

Figure 1: Schematic line set up at of line 1 and 4 at Navion Saga (not in scale).

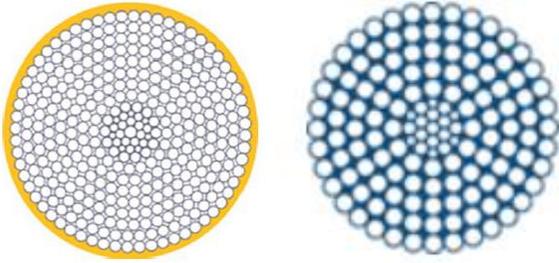
Figure 2: The investigative reports on Navion Saga do not show rope geometry. The pictures are examples of Bridon Xtreme spiral strand ropes found on Bridon's internet pages. The Navion Saga ropes had no outer protection sheath in 2011.

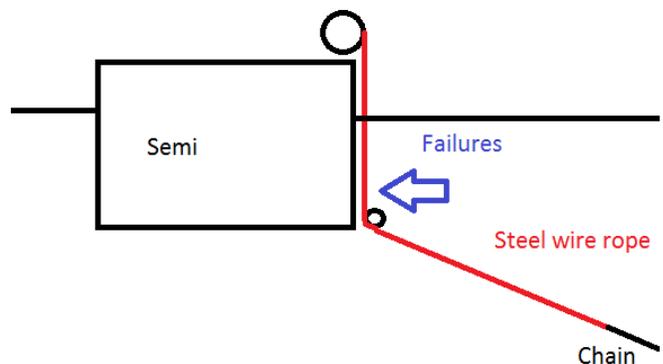
Figure 4: A schematic line setup on COSLPioneer. The figure is not in scale.

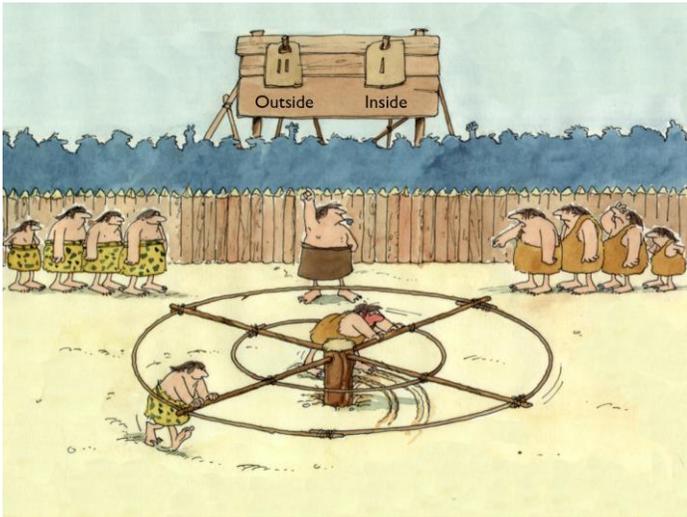
Figure 7: “Due to their longer lever arms the outer strands have an advantage” (Verreet, 2002).
