LOW ENERGY VESSEL COLLISIONS ON THE NORWEGIAN CONTINENTAL SHELF 1982-1994

Arne Kvitrud, Kåre Tesdal and Kjell L Nilsson
The Norwegian Petroleum Directorate,
P.O.Box 600, N-4000 Stavanger, Norway

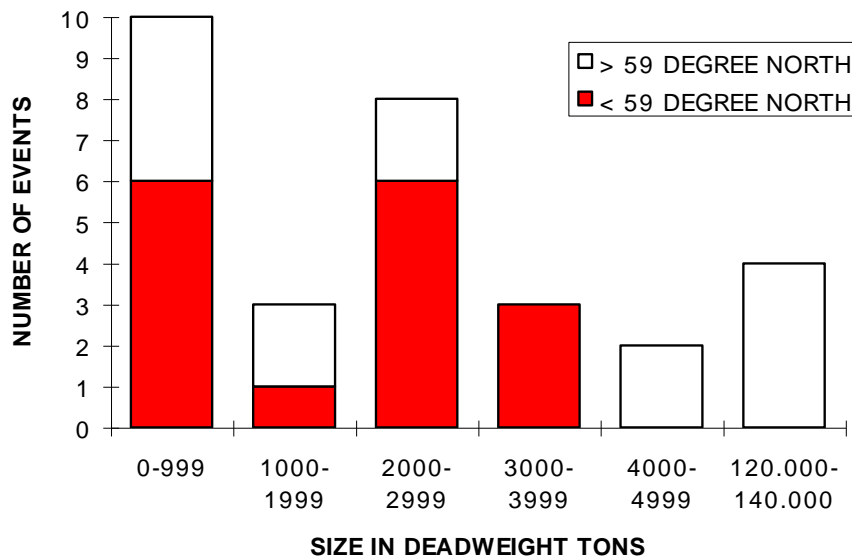
A relationship between the vessel sizes and the respective number of collisions is shown in fig. 3. The relative numbers of the smallest and largest vessels are much higher than reported from UK side (Ellinas, 1993). The sizes are mainly taken from Dayton (1987) and DnV (1986, 1988 and 1994). The reports don't give any information about the actual weight. The UK data (Ellinas, 1993) indicate differences in sizes between the vessels colliding in different parts of the UK sector. Ellinas has not defined the limits of south, central and northern North Sea, but a similar exercise on the Norwegian data, using 59 degree north as the boarder, give a distribution as showed on the figure 3. Neglecting the tanker collisions a geographical trend, as shown in the UK data, is not observable in the Norwegian data. Loading buoys in Norway are presently only used in the area north of 59 degree north.

Figure 3 : Size of the colliding vessels distributed on geographical location
