LEARNING FROM DYNAMIC POSITIONING EVENTS

Arne Kvitrud

Petroleum Safety Authority Norway (PSA)
Professor Olav Hanssens vei 10
NO-4003 Stavanger, Norway

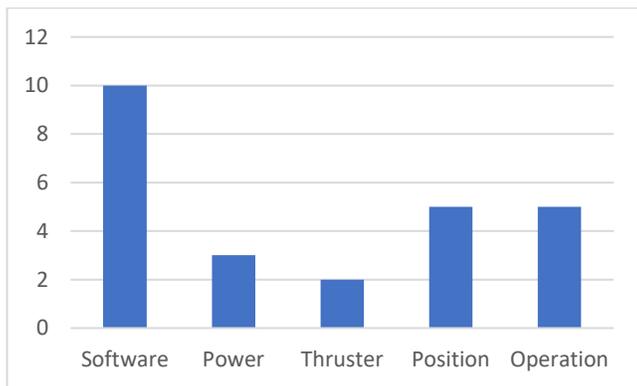
Figure 1: THE NUMBER OF EVENTS IN TABLE 1 RELATED TO THE MAIN CAUSES OF INCIDENTS. AS DESCRIBED IN TABLE 1, SEVERAL CASES HAVE MORE THAN ONE MAJOR CAUSE.

Table 1 and figure 1 are to a large extent the picture given by the platform or vessel owners in their investigation reports. They are explaining many of the cases as software problems. If the system or software suppliers had done the investigations, they may have questioned more if the use of the software had been

Many incidents and failure modes are reported world-wide on DP systems. *Chong-Ju Chae and Yun-Chul Jung (2015)* analysed the IMCA data for 612 DP loss of position incidents from 2001 to 2010, and found the main causes of incidents were on the position reference systems, followed by DP computers, power systems, human errors and thruster systems. My cause distribution in figure 1, is not significantly differently.

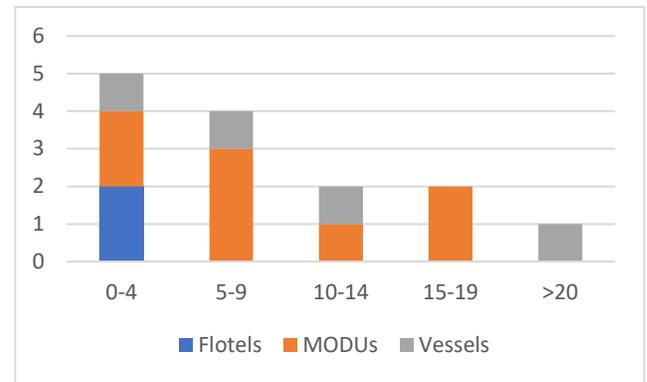
FIGURE 2: THE AGES OF THE UNITS (14X) WITH POSITION INCIDENTS REPORTED IN THE PERIOD 2014-2018. THE AGE IS AT THE TIME OF THE INCIDENTS, IN YEARS.

The ages of units show a normal age decay function, where most problems are observed early. Two of the units were less than one year old when the incidents occurred. Reviewing the most critical cases, the pollution cases happened on one unit that were less than one year old, one was six years and one was 16 years. The autolift cases occurred on units with ages less than five years. It is fair to say, that the youngest units had a higher occurrence of severe cases than the others. This behaviour is usually explained as deficiencies in design, fabrication and commissioning, together with unsatisfactory quality control or verifications. Since known errors usually are corrected, the number of faults are reduced over time, and so are the number of incidents. Important contributors to errors on new vessels are also new crews, new complex facilities, lack of vessel specific training and knowledge of the vessels, and how it behaves under the prevailing conditions. This is the same as our experiences on shuttle tanker incidents (Kvitrud et al, 2012).

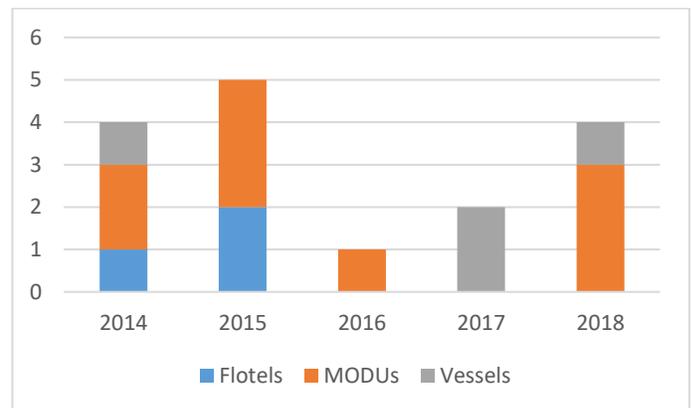
FIGURE 3: POSITION INCIDENTS (16X) REPORTED IN THE PERIOD 2014-2018, AS FUNCTION OF THE INCIDENT YEARS.

A temporary drop in number of incidents occurred in 2016, but no clear trend is visible. A correlation between the drop of oil prices and reduced activities versus the changes in incidents do exist, but the tables and figures are not normalized for changes in the activities and the number of DP units in use.
