OMAE2011-49897

COLLISIONS BETWEEN PLATFORMS AND SHIPS IN NORWAY IN THE PERIOD 2001-2010

Arne Kvitrud

Petroleum Safety Authority (PSA)
Professor Olav Hanssens vei 10
NO-4003 Stavanger, Norway

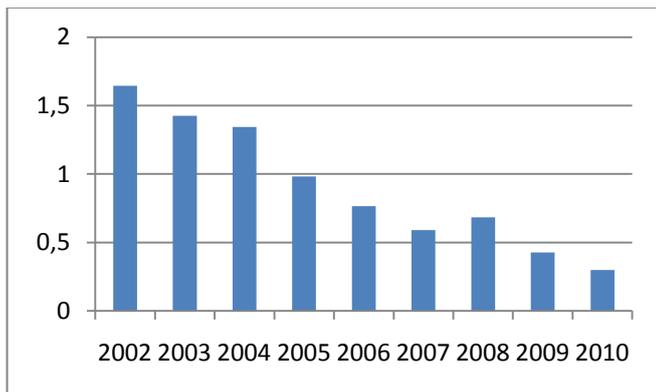
Figure 1: The annual number of ships on collision course, divided with the number of platforms surveyed. All the data are observed from Sandsli Maritime Control Centre. The figure is made from data collected by Jan Erik Vinnem (PSA, 2011).

To monitor the ship collision risk from passing vessels, the number of vessels on collision course is counted annually from the Statoil Maritime Control centre at Sandsli. These are situations where the direction of the vessel is inside the safety zone, and no contact has been established with the vessel within 25 minutes before a possible hit, or vessels or helicopters are mobilized against the approaching vessel. Fishing vessels in low speed and small ships (as sailing ships) are not counted. Since the number of platforms surveyed is not constant, the number of vessels on collision course is normalized with the number of platforms surveyed. As demonstrated in figure 1, the relative number of ships on collision course has improved for several years, with a factor of about four since 2002. The number of violations of the safety zones is also low (figure 2).

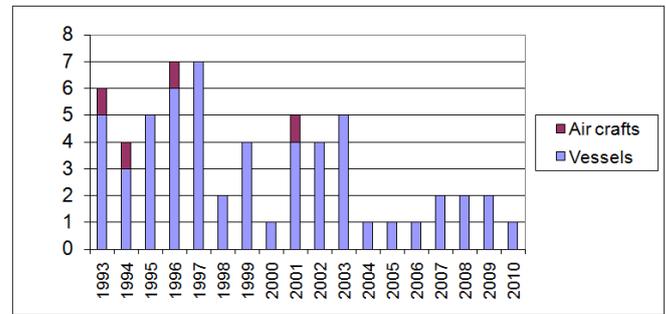
Figure 2: The annual number of violations of the safety zones in Norway 1993-2010.

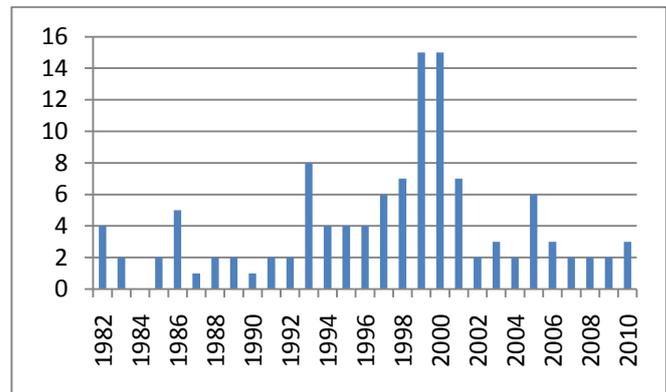
Figure 3: The annual number of collisions between vessels and platforms in the period 1982-2010.

Except for the two collisions with passing vessels mentioned above, all the collisions in figure 3 have been with visiting vessels.

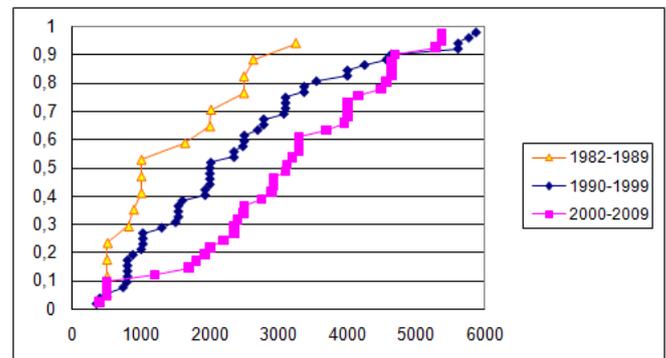
Figure 4: Cumulative distribution of size of vessels (excluding tankers) in deadweight tons that have collided from 1982 to 2009.

Comparing the sizes of the colliding vessels, we can see from Figure 4 that the average size of vessels has increased by about 100 tons a year since the 1980s. Collision energy increases proportionally with the size of the vessels, causing the average vessel to be capable of causing much more damage than 20 years ago. The collisions with tankers are not included in the figure.

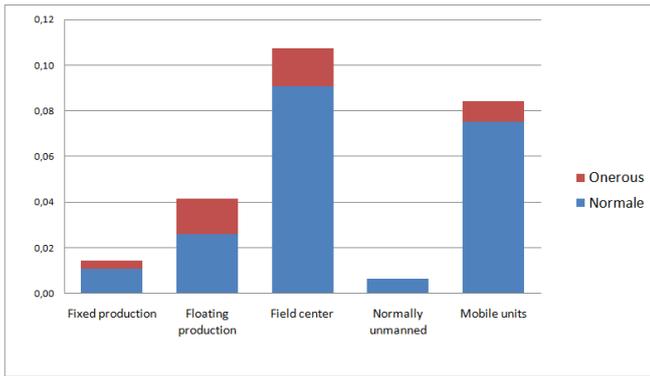
Figure 5: Collisions per platform year as function of type of platform from 2000 to 2010. The onerous collisions are the collisions described in the next chapter.

There are major differences in collision frequencies on different platform types, as shown in figure 5. Field centres and mobile platforms have the highest collision frequencies. A field centre consists of two or more bridge connected platforms, but in the statistics they are calculated as one unit.

Of the manned platforms, the fixed production platforms have the lowest collision frequency.
