Requirements to and in service experiences of jack-ups in Norway

Presented at the Thirteenth International Conference, The Jack-Up Platform, Design, Construction & Operation, London, September 13th – 14th 2011.

By Arne Kvitrud, Petroleum Safety Authority (PSA), Stavanger, Norway.

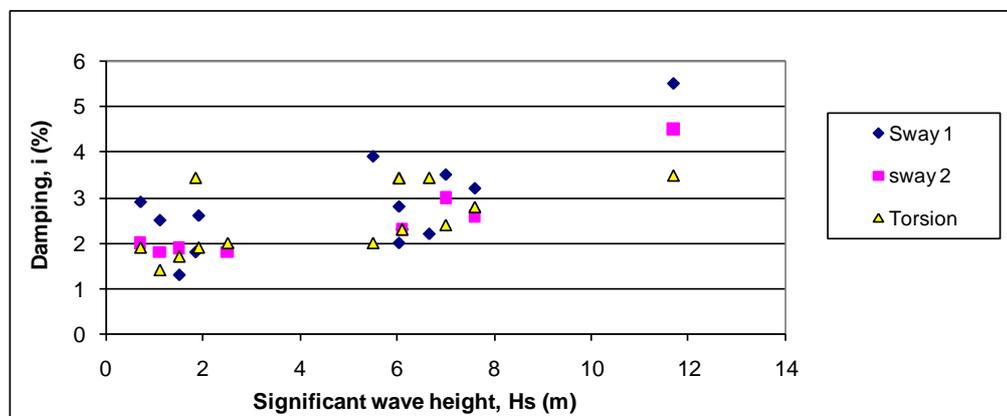
Figure 1: Damping in % for the first three vibration modes of Mærsk Guardian on Ekofisk 2/4-W and Silver Pit plotted against Hs (in meters), based on information in [23] and [2].

Sterndorff [19] have examined the Mærsk Guardian for winter 1990/1991 at Ekofisk. He states the first own period to be 5.95 seconds in the largest storm. I have plotted his damping values against H_s (in meters) as in figure 1.
